ABOVE AND UNDERWATER PILE INSPECTION REPORT

MAGNOLIA PIER MAGNOLIA HARBOR, GLOUCESTER, MA

September 2015

File No. 18.0172459.00
Copyright© 2015 GZA GeoEnvironmental, Inc.

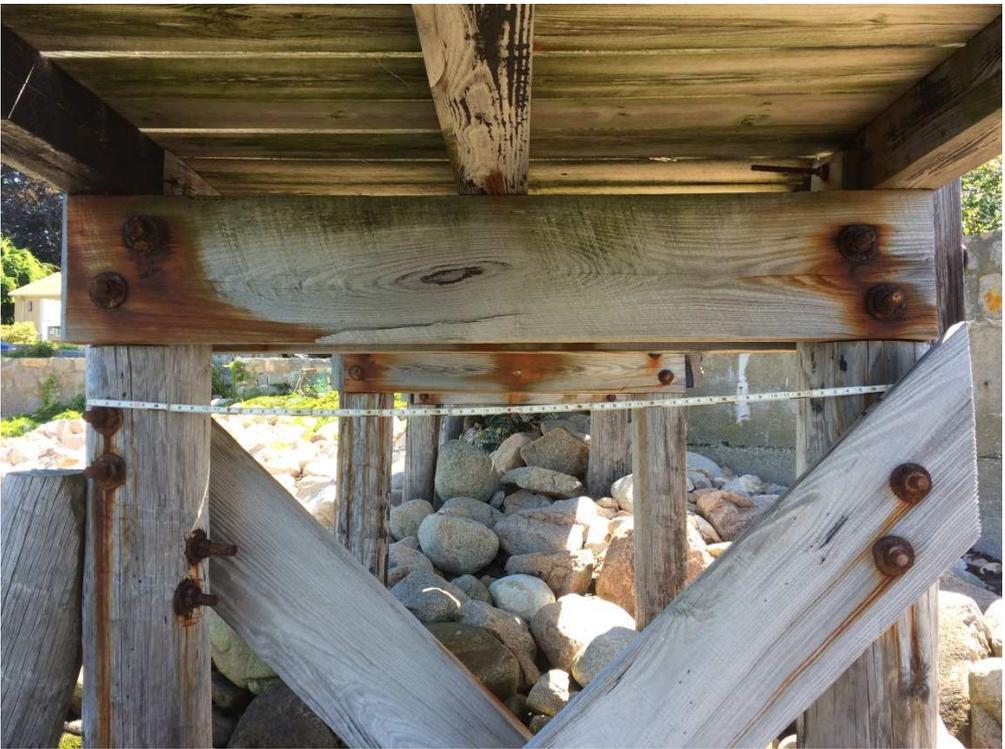
Photo No. 8	Date: 08/06/15

Direction Photo Taken: Easterly		
Description: Typical pier framing. Note: 6x6 timber stringers spaced at $\pm 2.5\text{'-}3\text{'}$ o.c. with apparent creosote treatment and corroded fasteners.

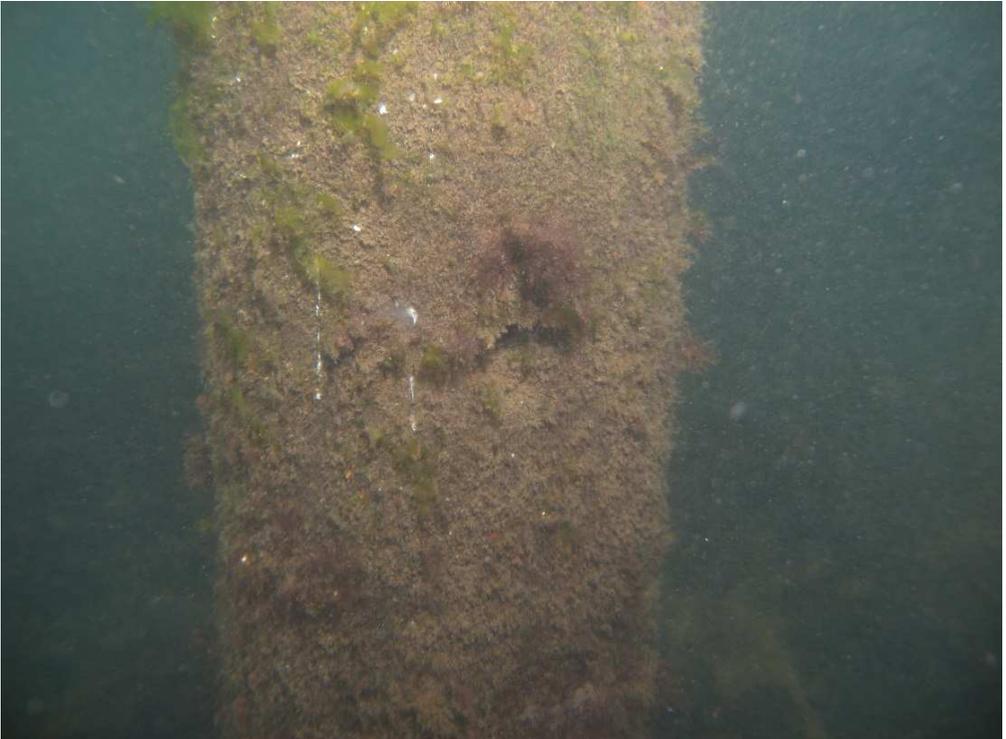
Client Name: City of Gloucester Harbormaster		Site Location: Magnolia Pier	Project No. 18.0172459.00
Photo No. 11	Date: 08/21/15

Direction Photo Taken: -			
Description: Typical minor to moderate marine borer damage on timber piles.

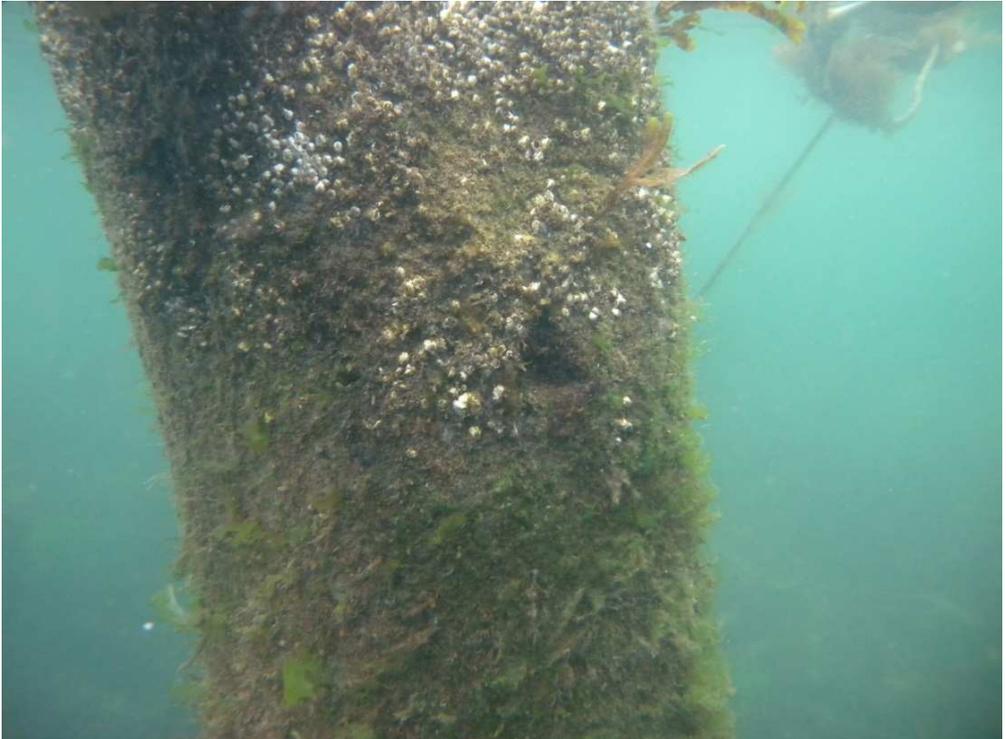
Photo No. 12	Date: 08/21/15

Direction Photo Taken: -			
Description: Typical minor to moderate marine borer damage on timber piles.

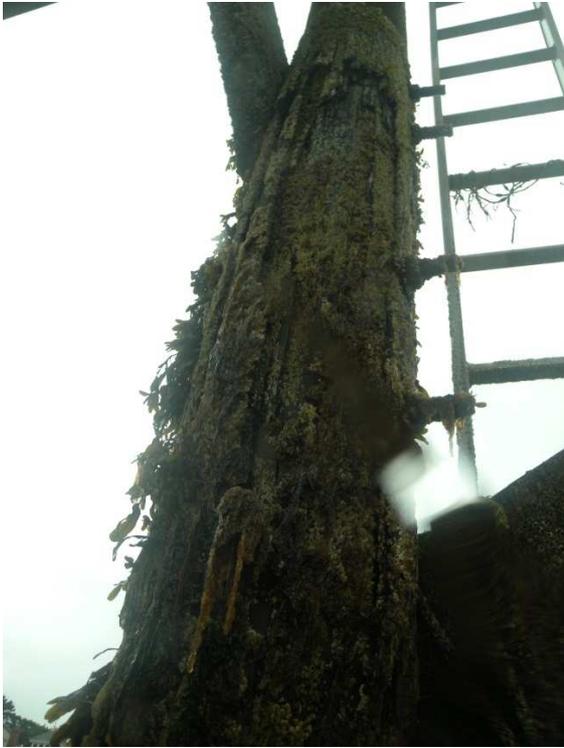
Client Name: City of Gloucester Harbormaster		Site Location: Magnolia Pier	Project No. 18.0172459.00
Photo No. 13	Date: 08/21/15

Direction Photo Taken: -			
Description: Moderate to severe deterioration/delamination of timber pile within tidal zone.

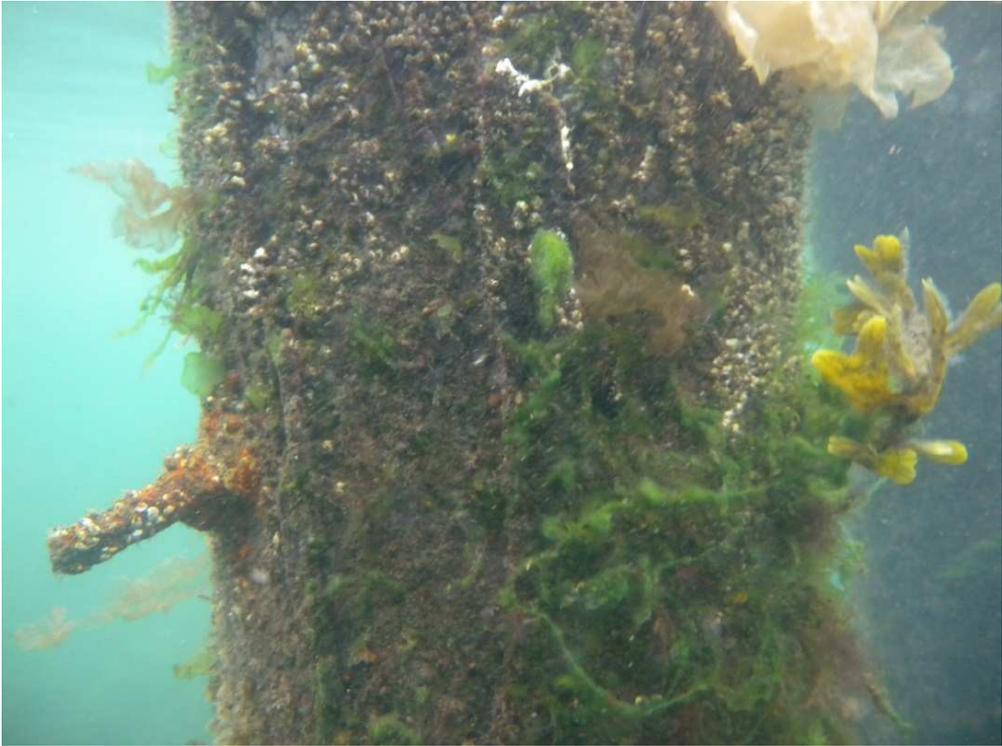
Photo No. 14	Date: 08/21/15

Direction Photo Taken: -		
Description: Minor to moderate delamination/trenching of timber pile.

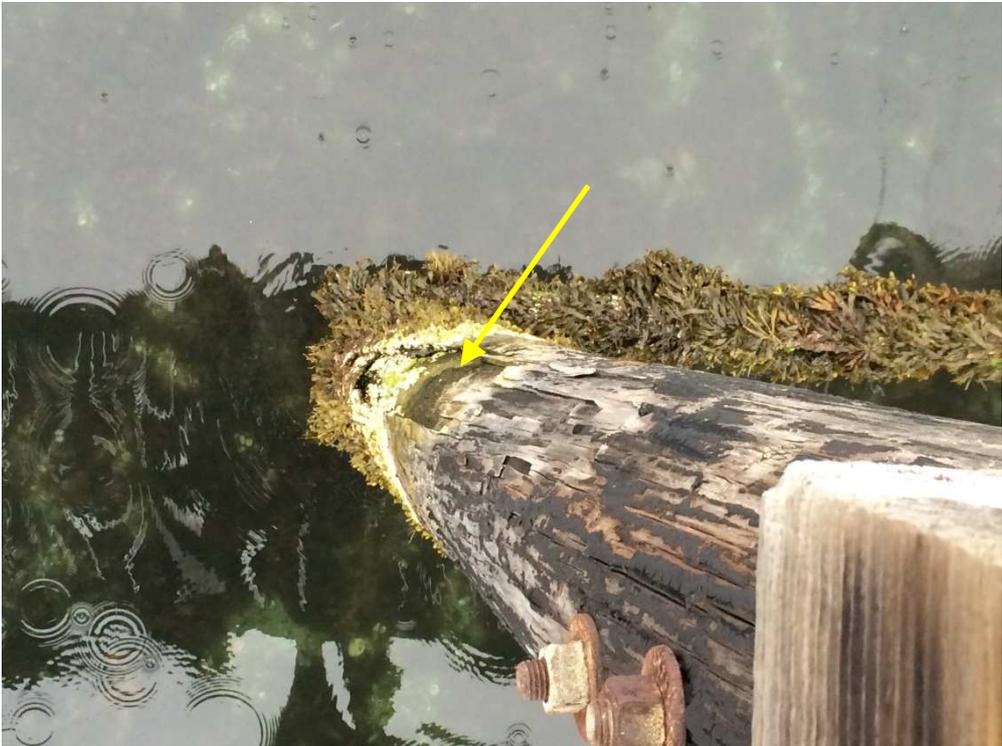
Client Name: City of Gloucester Harbormaster		Site Location: Magnolia Pier	Project No. 18.0172459.00
Photo No. 15	Date: 08/21/15

Direction Photo Taken: -			
Description: Minor to moderate deterioration/delamination of timber pile within tidal zone.

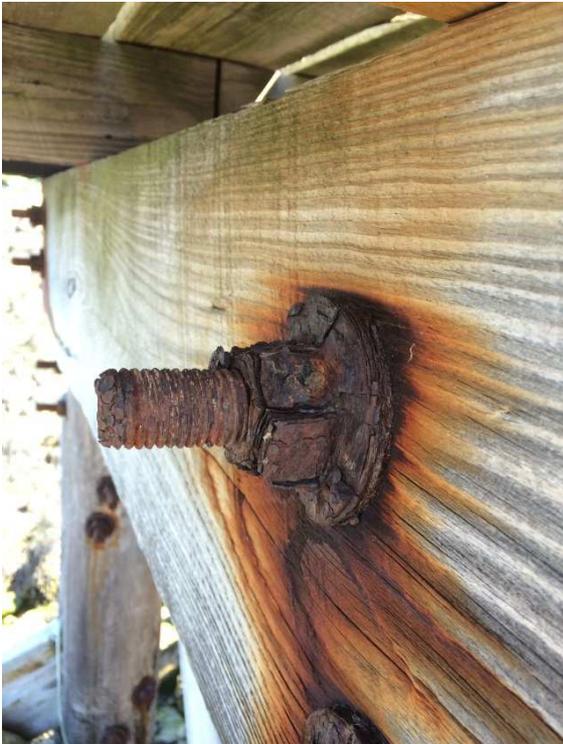
Photo No. 16	Date: 08/06/15

Direction Photo Taken: -		
Description: Typical corrosion of steel fasteners.

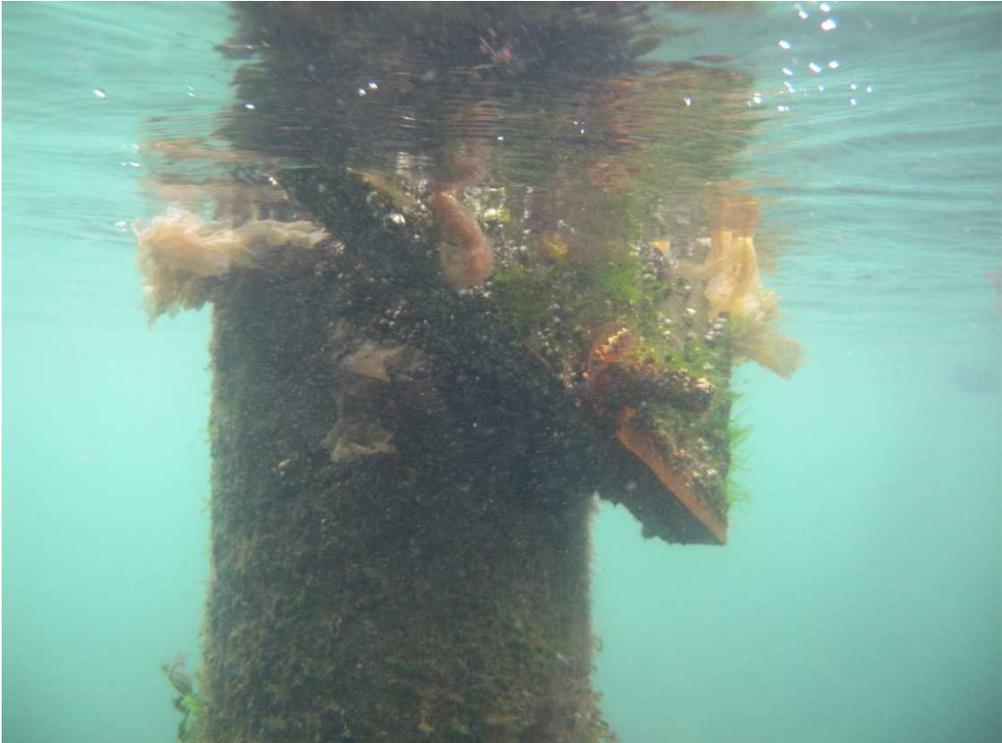
Client Name: City of Gloucester Harbormaster		Site Location: Magnolia Pier	Project No. 18.0172459.00
Photo No. 17	Date: 08/21/15

Direction Photo Taken: -			
Description: Typical corrosion of steel fasteners within tidal zone.

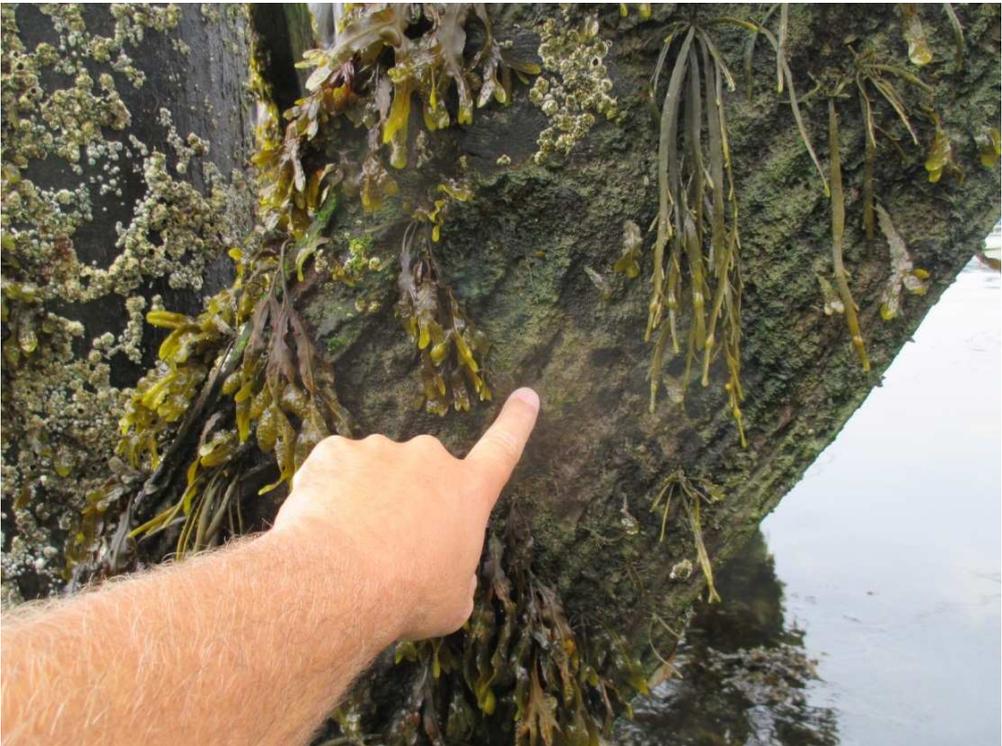
Photo No. 18	Date: 08/21/15

Direction Photo Taken: -		
Description: Typical minor to moderate deterioration of lower cross bracing members.

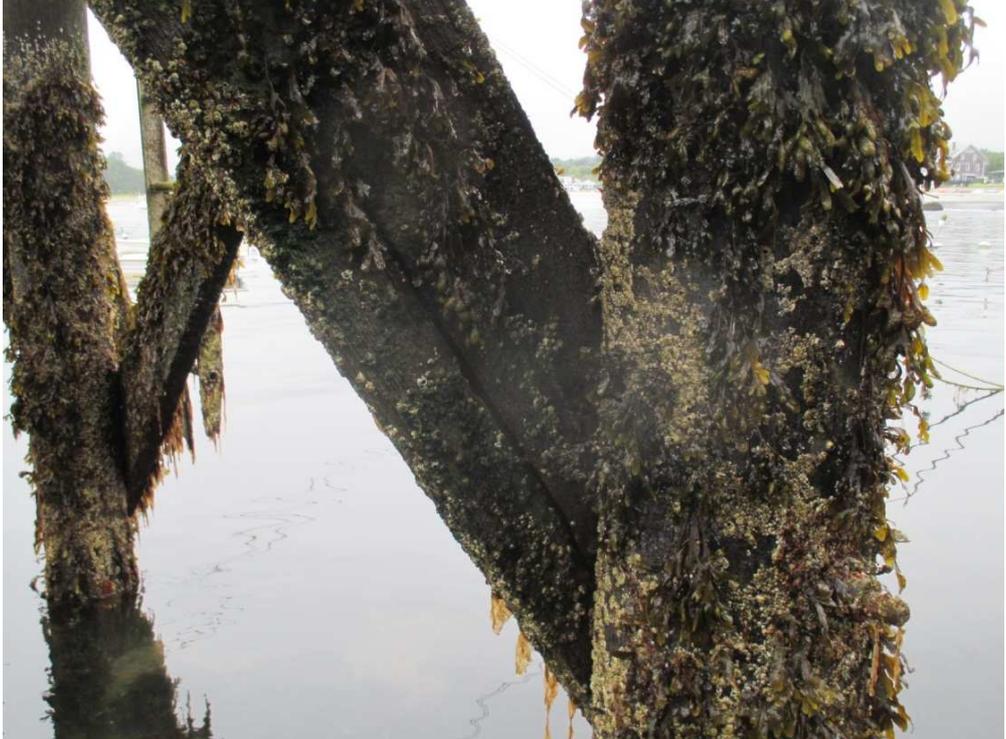
Client Name: City of Gloucester Harbormaster		Site Location: Magnolia Pier	Project No. 18.0172459.00
Photo No. 19	Date: 08/21/15

Direction Photo Taken: -			
Description: Typical minor to moderate deterioration of lower cross bracing members.

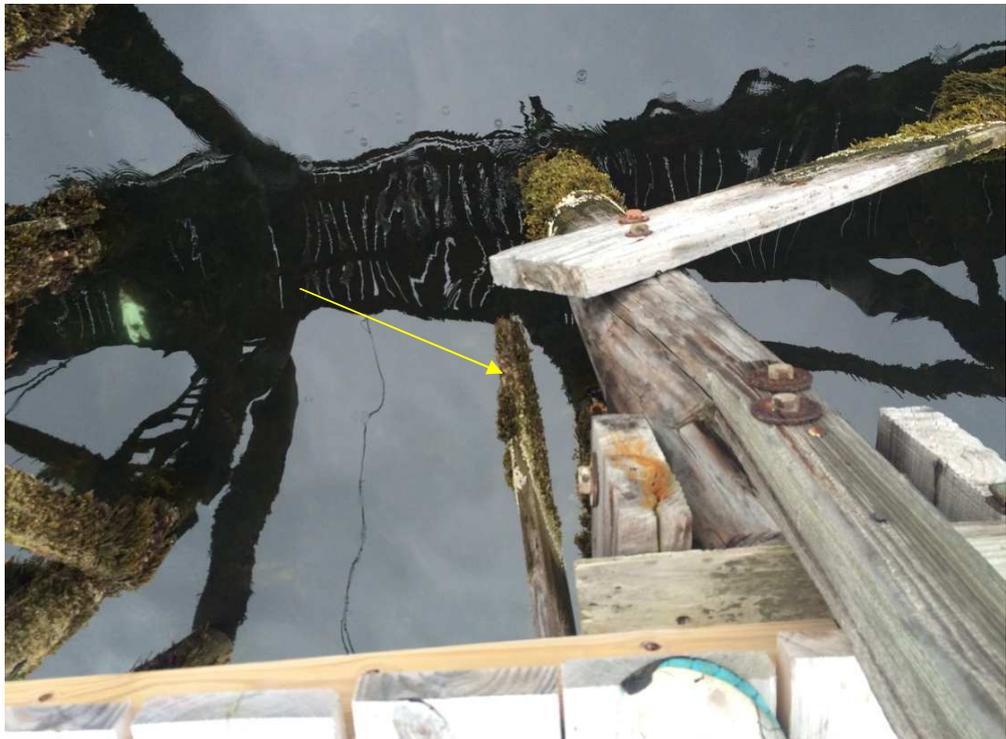
Photo No. 20	Date: 08/21/15

Direction Photo Taken: -			
Description: Disconnected cross bracing member at Bent 15.

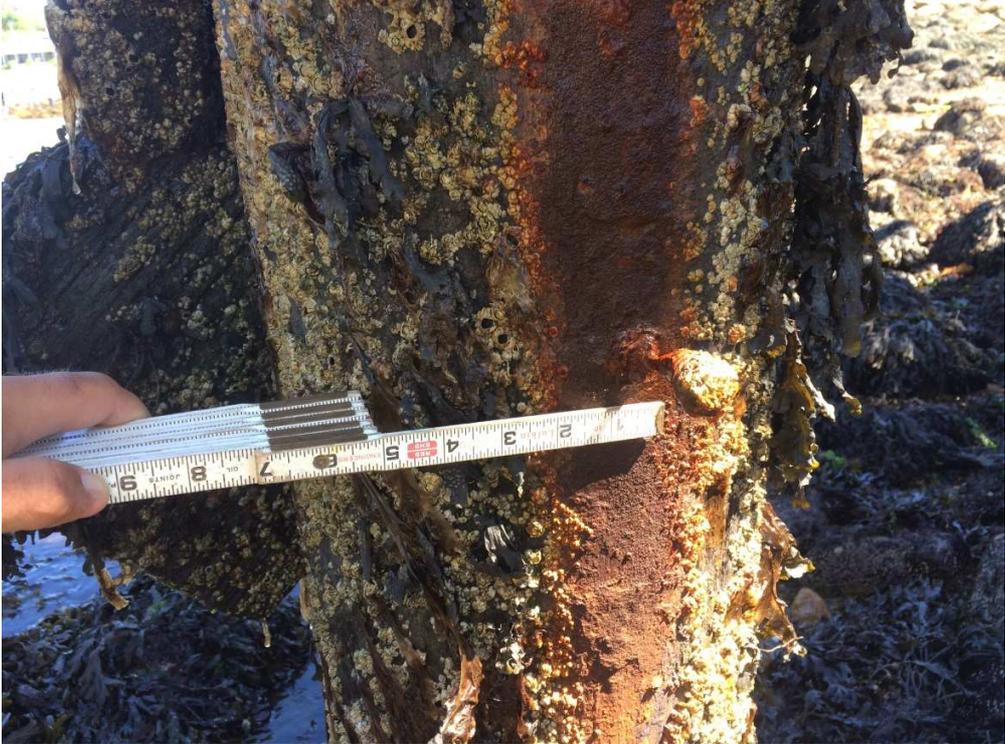
Client Name: City of Gloucester Harbormaster		Site Location: Magnolia Pier	Project No. 18.0172459.00
Photo No. 21	Date: 08/06/15

Direction Photo Taken: -			
Description: Deteriorated fastener.

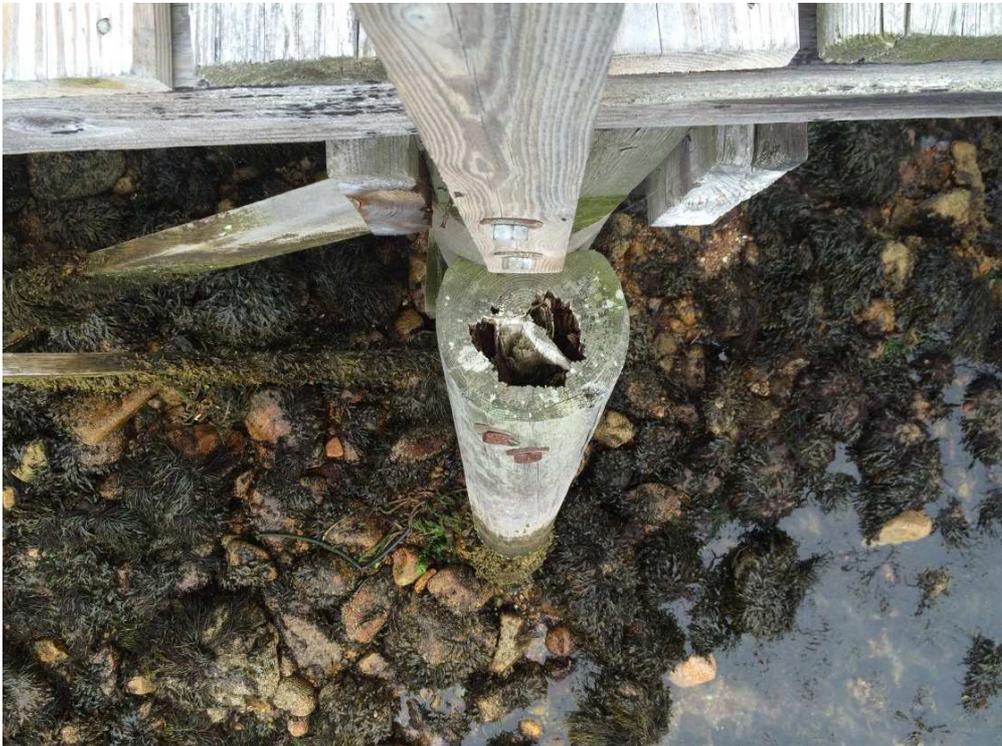
Photo No. 22	Date: 08/21/15

The overall observed condition of the timber pier piles ranged from **Fair** to **Good**, with limited areas of **Poor** to **Serious** condition observed on the timber batter piles. Minor to moderate damage due to marine borer action was observed on approximately 40 percent of piles (See Photographs 11-15 and Table 1 below). Minor to severe corrosion was observed on the majority of hardware connections within the tidal zone with total corrosion loss on the bolt and nut at one location (see Photographs 16 and 21). Minor to moderate deterioration was observed on the majority of lower cross bracing members in addition to isolated cases of disconnected or broken members (See Photographs 17-20). Approximately 2 piles had significant rot and/or significant section loss at the top of the pile (See Photographs 22-23).

Direction Photo Taken: -			
Description: Moderate to major deterioration in top of batter pile. Approximately 60% loss of section.

Based on the approximate age of the piles and the conditions observed, the timber pier support piles are estimated to have approximately 5 to 10 years of useful life remaining before repairs or replacement should be considered. Due to the deterioration and rot observed on the tops of the timber batter piles and corroded connections, repairs or replacement of these elements should be considered within the next 1 to 3 years, or sooner if conditions worsen. The remaining timber support piles, based on the deterioration observed from marine borers should be considered to be repaired or replaced within 5 to 10 years, or sooner if conditions worsen.

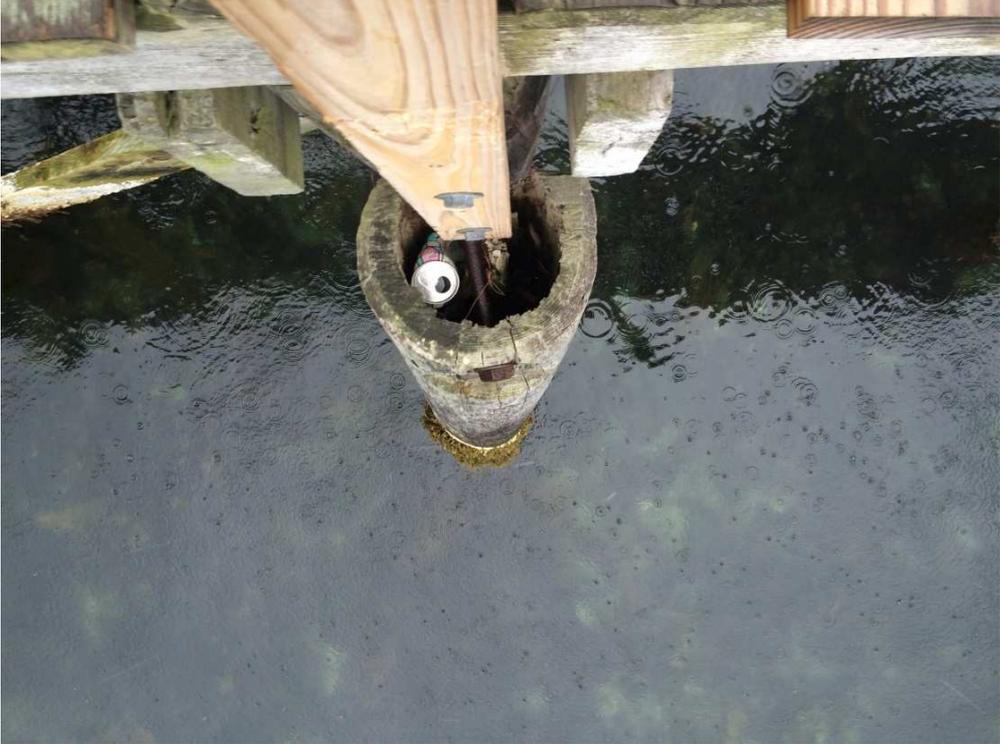
Client Name: City of Gloucester Harbormaster		Site Location: Magnolia Pier	Project No. 18.0172459.00
Photo No. 23	Date: 08/21/15

Direction Photo Taken: -			
Description: Moderate to major deterioration in top of batter pile. Approximately 80 to 90% loss of section.

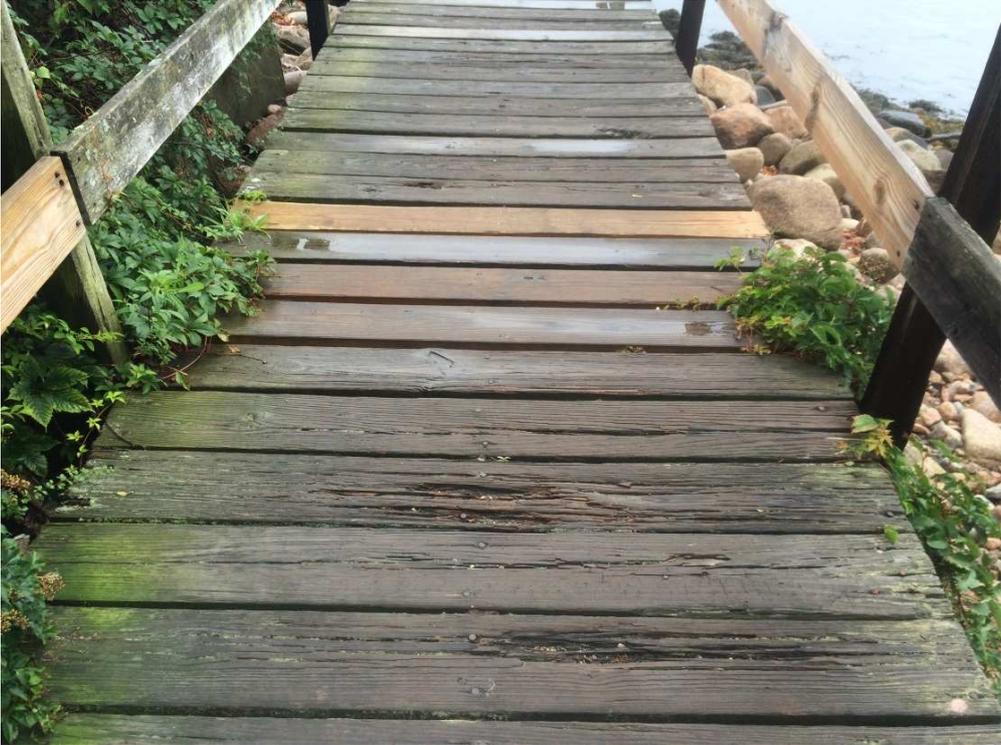
Client Name: City of Gloucester Harbormaster		Site Location: Magnolia Pier	Project No. 18.0172459.00
Photo No. 25	Date: 08/21/15

Direction Photo Taken: Westerly			
Description: Typical condition of older decking members. Note: Moderate checking and splitting.

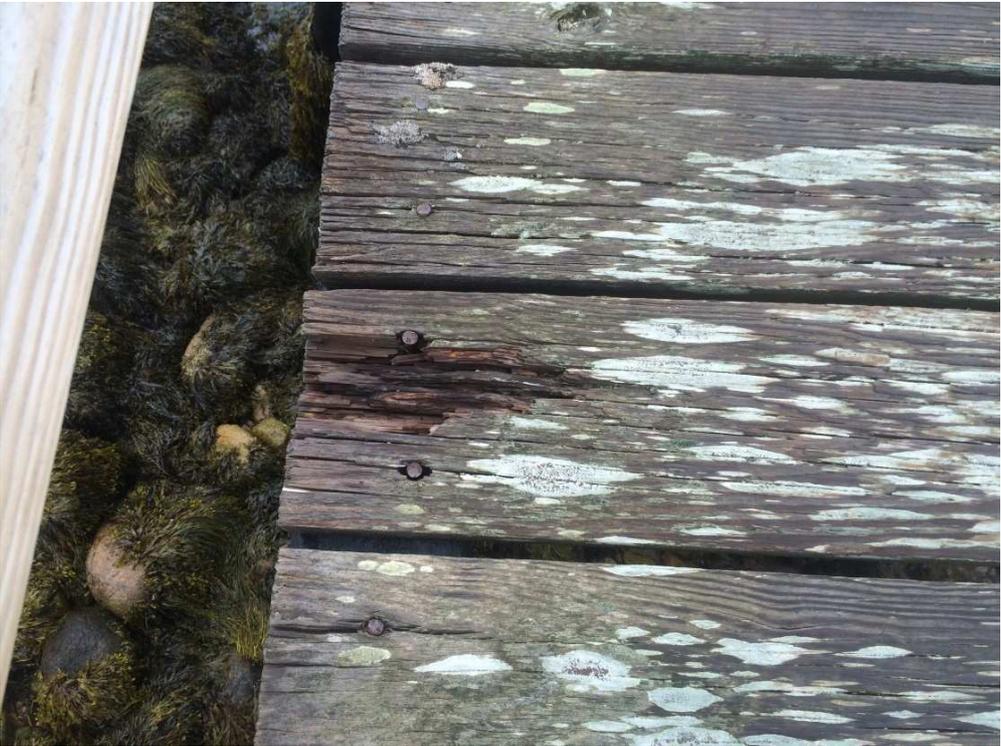
Photo No. 26	Date: 08/21/15

Direction Photo Taken: -			
Description: Typical condition of older deck member. Note: Moderate to severe check.
