**Enclosure 2** for your information is a memorandum and a copy of the Facilities Capital Management Report

# Facilities Capital Management Report

Phase I: Discussion  
February, 2010

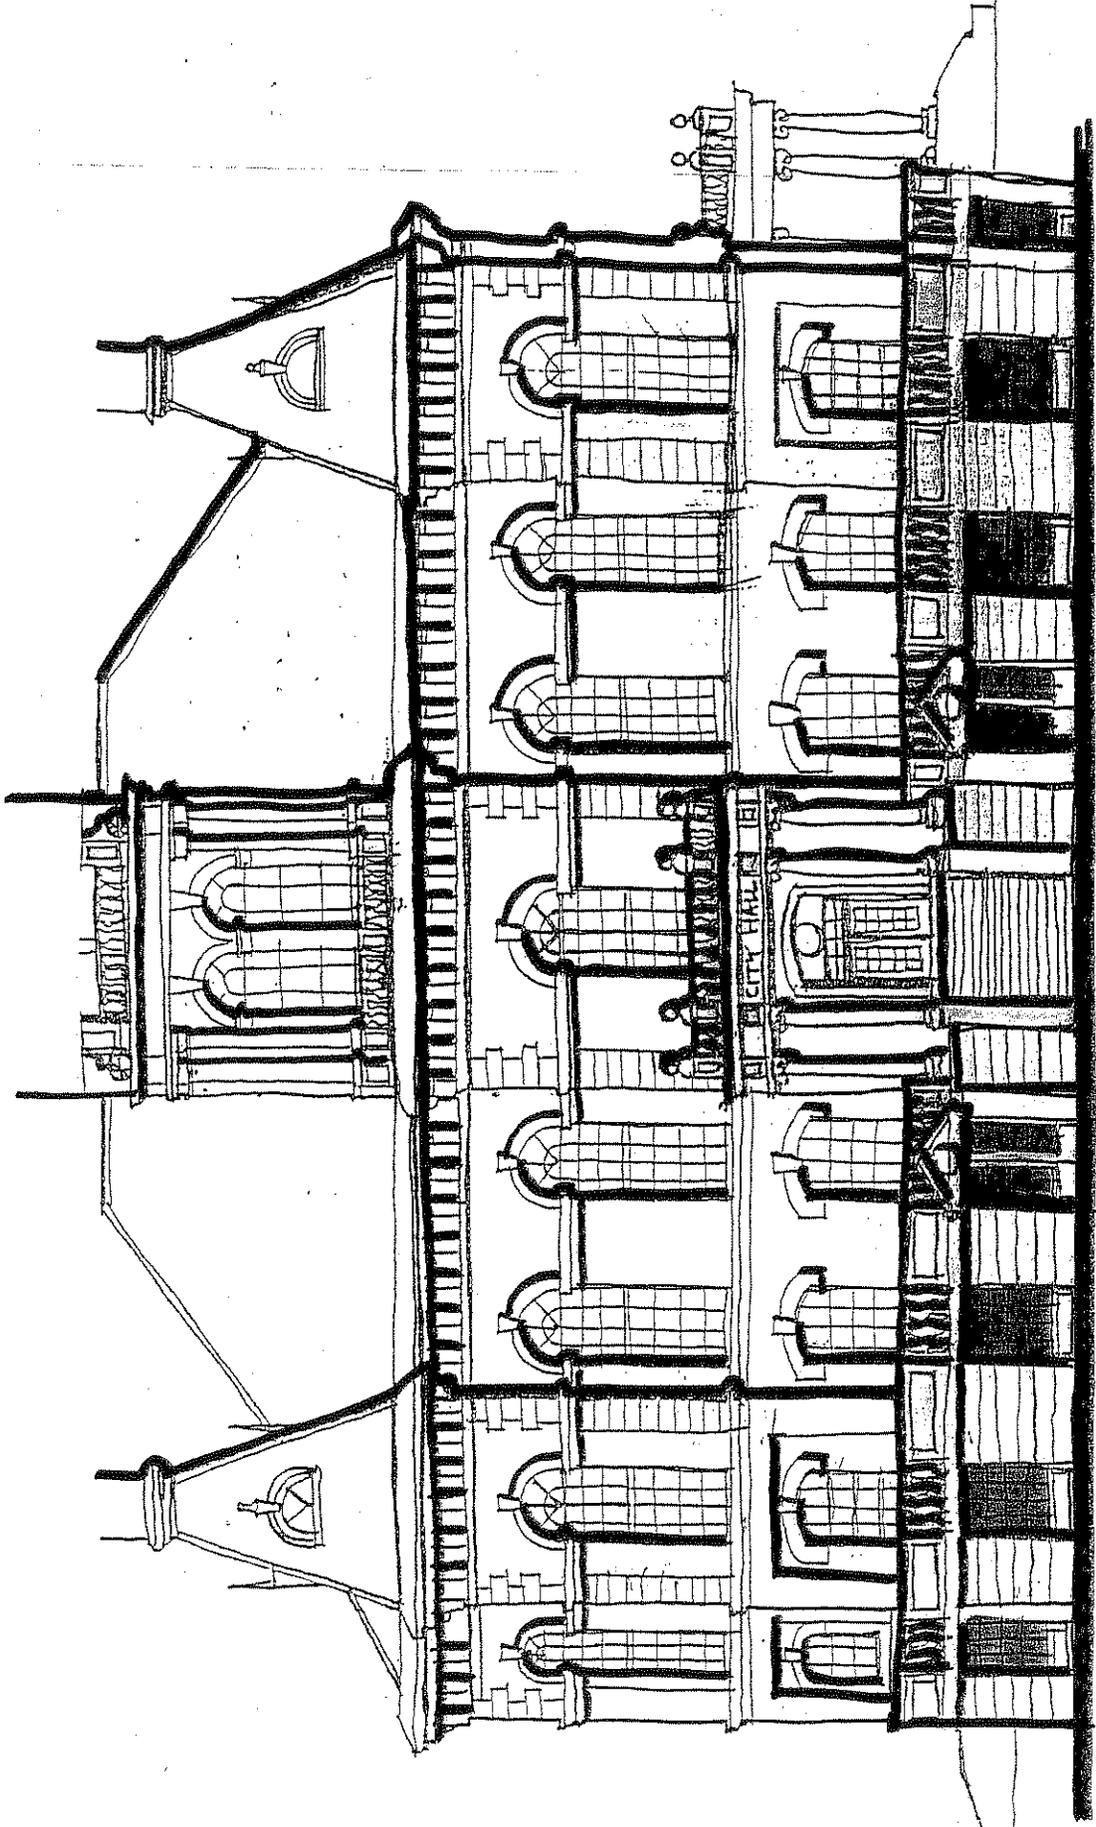
PODIUM FROM DALE AVENUE  
(PHASE I COMPLETED)

Our next step was to see what could be added to City Hall by constructing podiums on three sides. Such a solution would retain the existing parking, at a level only a couple of feet higher than at present. A series of three site plan sketches are attached, showing the present condition, the plan with a front podium housing 7500 additional square feet of prime space, and the maximum podium expansion, offering a total of 16,600 new square feet. We suspect that such a phased plan would extend the useful life of City Hall by at least another hundred years.
