**206 Main St., Gloucester, Massachusetts  
Weston & Sampson Project No. 2130191**

Mr. Stephen Winslow  
Senior Project Manager  
Community Development Department  
3 Pond Street  
Gloucester, Massachusetts 01930  
**RE: Hazardous Building Materials Investigation  
206 Main Street  
Gloucester, Massachusetts**

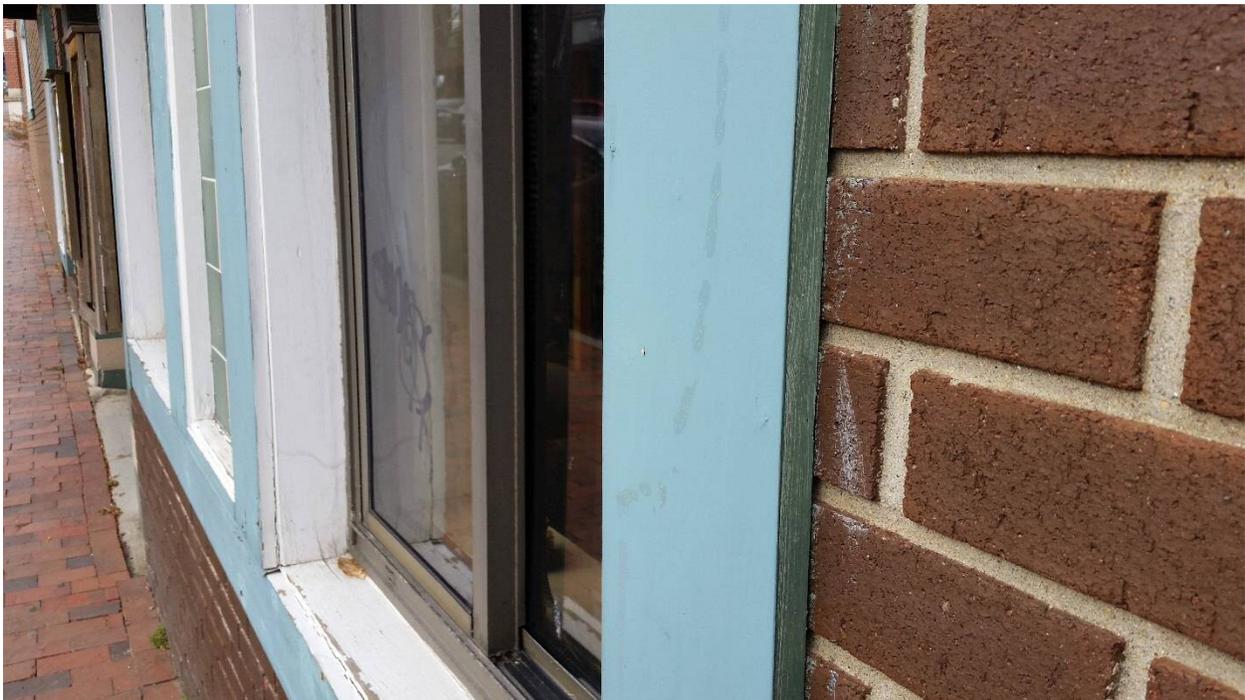
Exterior windows note lack of caulk

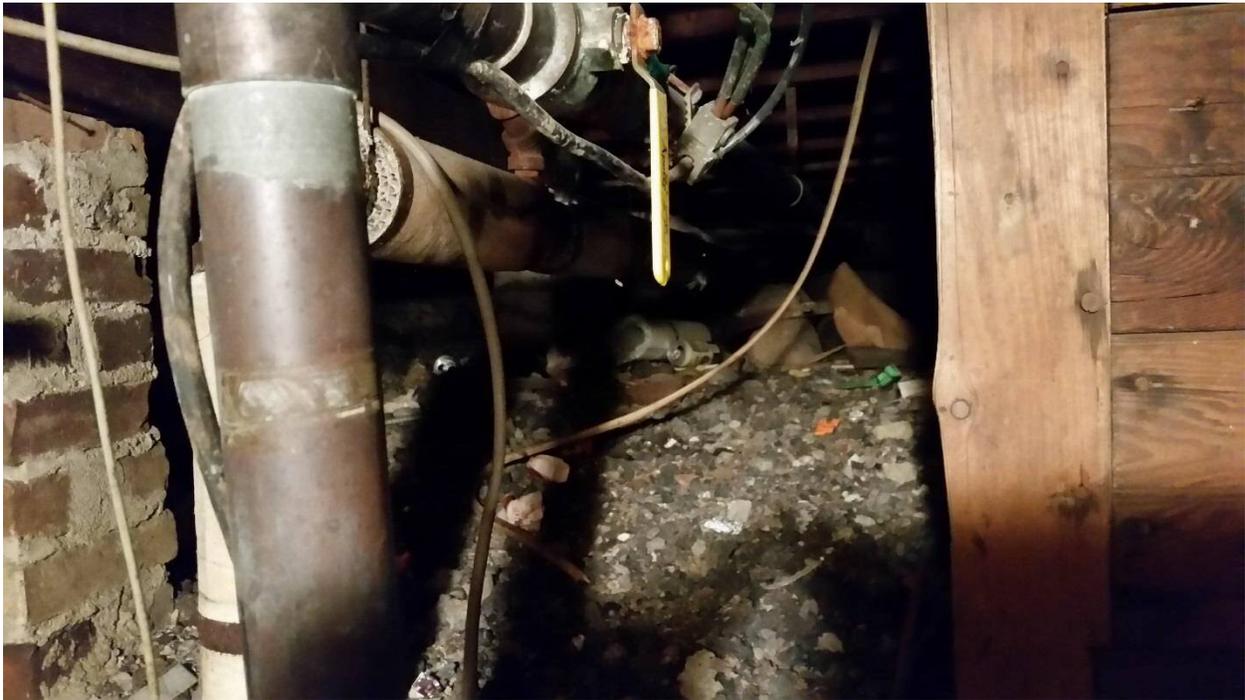
<sup>2</sup>Material appears to be have impacted soil in crawlspace.

Several small pieces of asbestos pipe insulation were observed in the soil of the basement crawlspace. Based on the size of the space and the general appearance of the pipe insulation some removal and disposal of soil will be required. However, the extent of contamination is not known as the space is inaccessible; the quantity provided is a best estimate based on observed conditions.

Pipe insulation in basement crawlspace

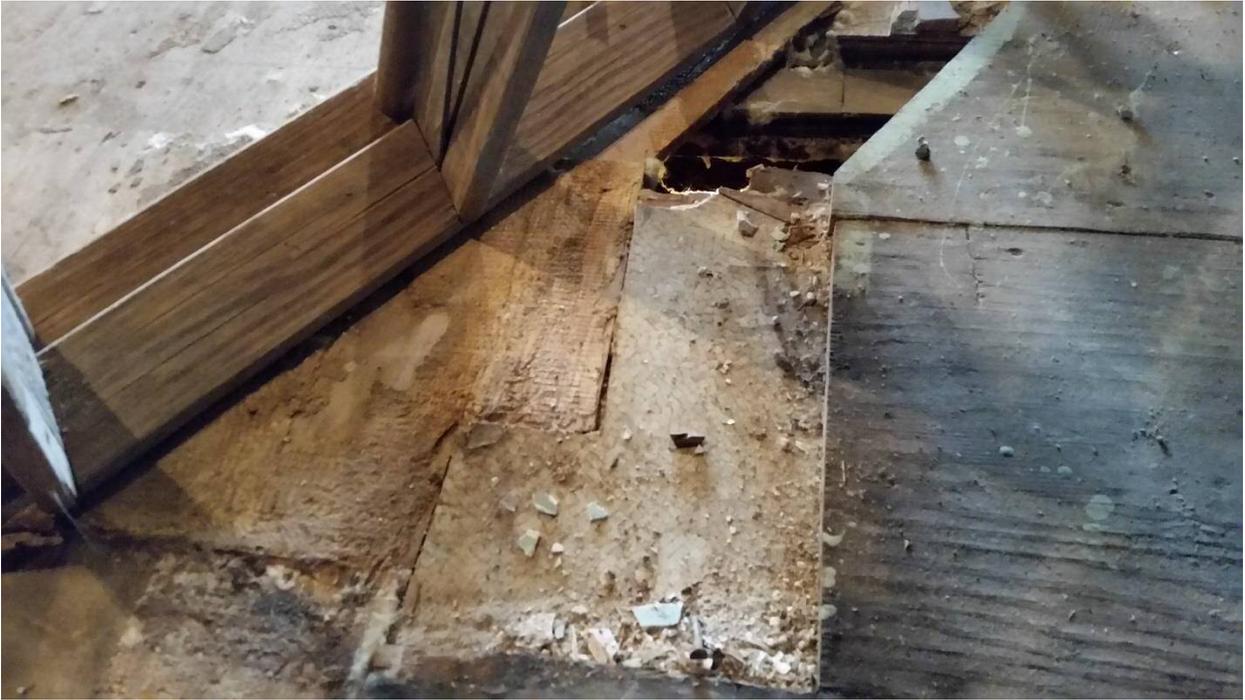
<sup>1</sup>Due to the presence of concealed ACM flooring in at least one location, additional concealed materials are likely present.

Linoleum concealed by wood flooring
