ABOVE AND UNDERWATER PILE INSPECTION REPORT

MAGNOLIA PIER MAGNOLIA HARBOR, GLOUCESTER, MA

September 2015

File No. 18.0172459.00
Copyright© 2015 GZA GeoEnvironmental, Inc.

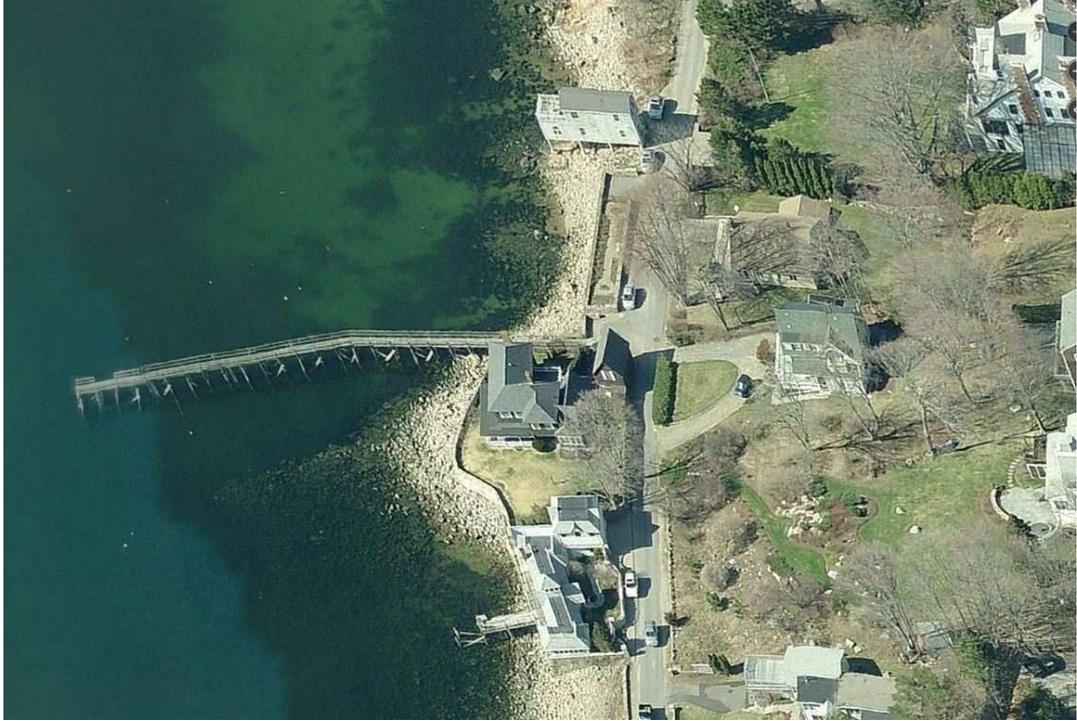
Client Name: City of Gloucester Harbormaster		Site Location: Magnolia Pier	Project No. 18.0172459.00
Photo No. 1	Date: 2015

Direction Photo Taken: Aerial			
Description: Aerial view of Magnolia Pier.

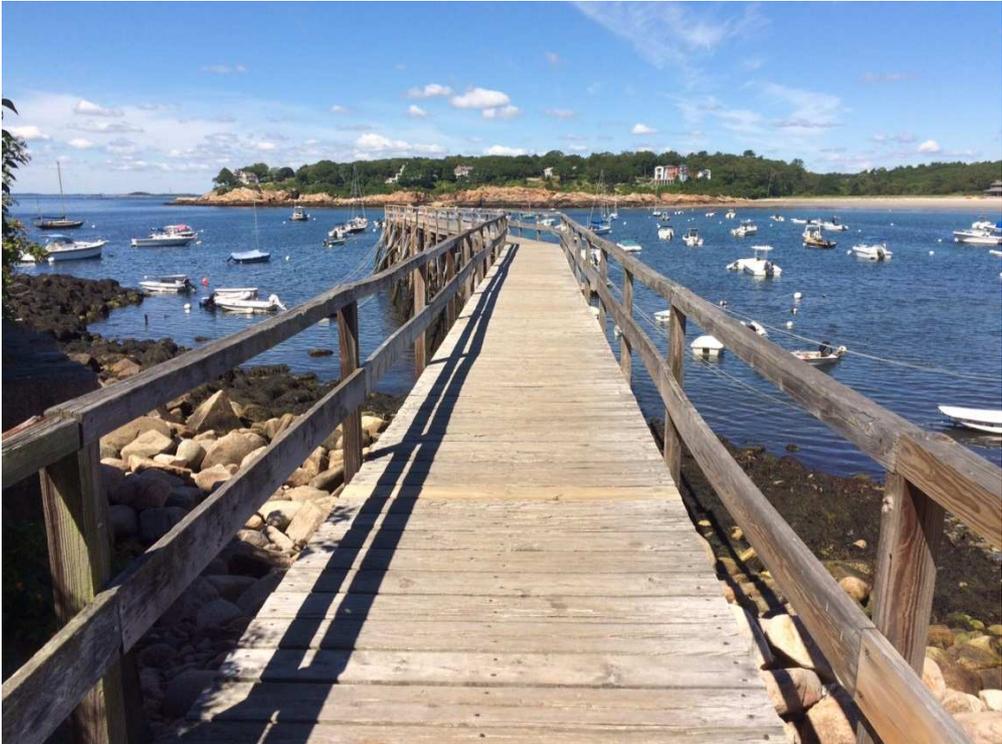
Photo No. 2	Date: 08/06/15

Direction Photo Taken: Westerly		
Description: Topside view of Magnolia Pier.

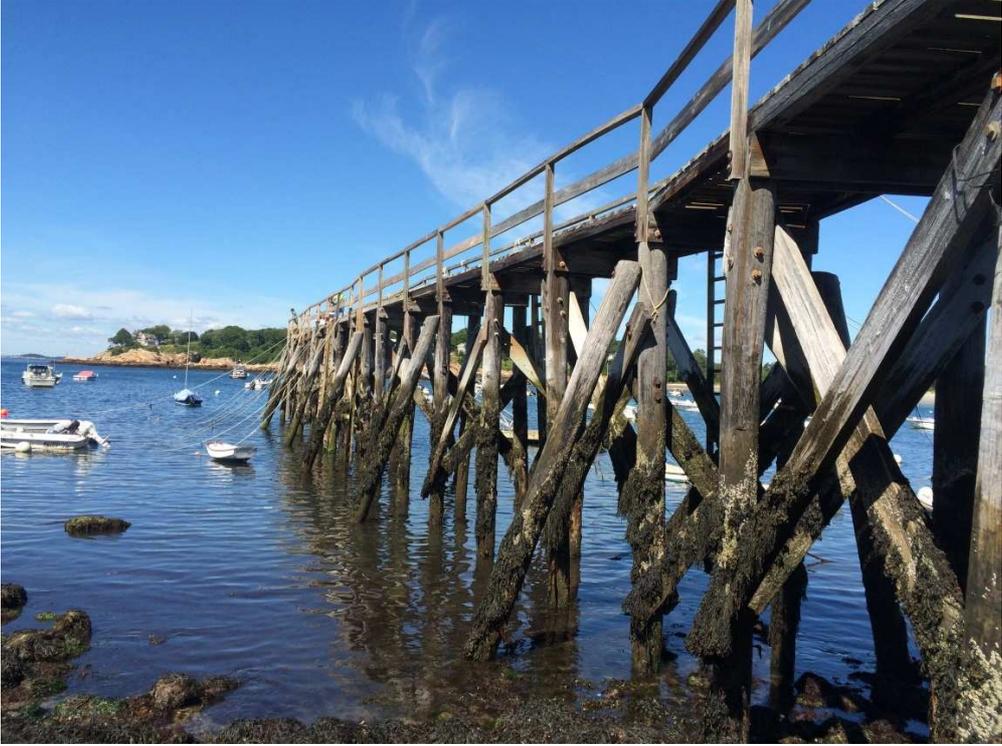
Client Name: City of Gloucester Harbormaster		Site Location: Magnolia Pier	Project No. 18.0172459.00
Photo No. 3	Date: 08/06/15

Direction Photo Taken: Westerly			
Description: View of Magnolia Pier along outer, south side.

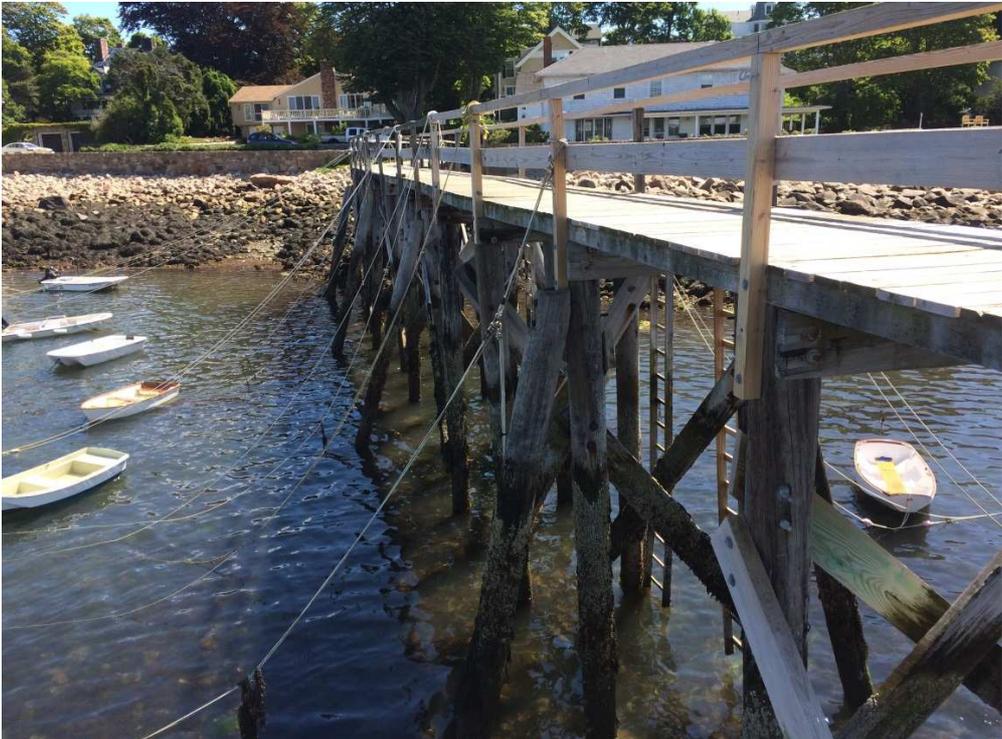
Photo No. 4	Date: 08/06/15

Direction Photo Taken: Easterly			
Description: View of Magnolia Pier, along north side. Note: Ladders on either side of pier provide access to dinghies.

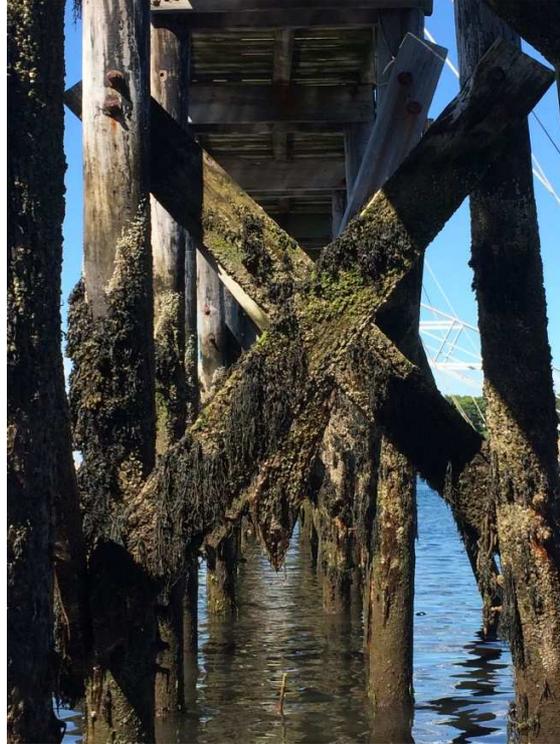
Description:
Underside of Magnolia Pier. Note: Timber cross bracing, timber piles and timber framing members.

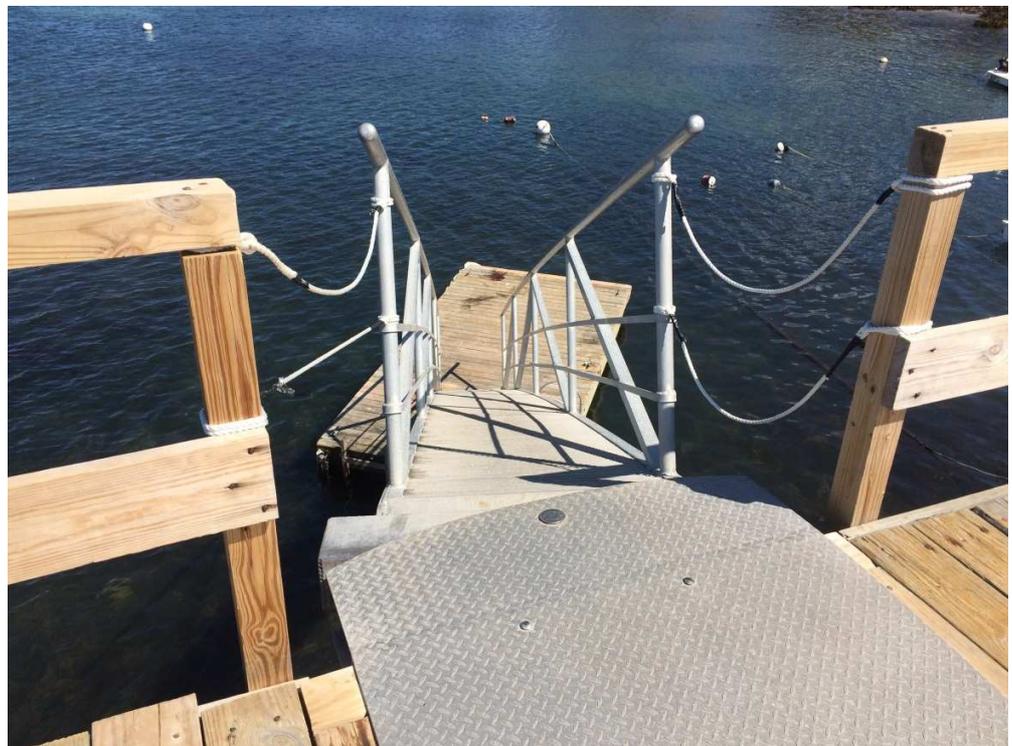
Photo No. 6	Date: 08/06/15
-----------------------	--------------------------

Description:
Aluminum gangway leading to seasonal bottom-anchored timber float. Note: Observed orientation of float different on 08/21/15.

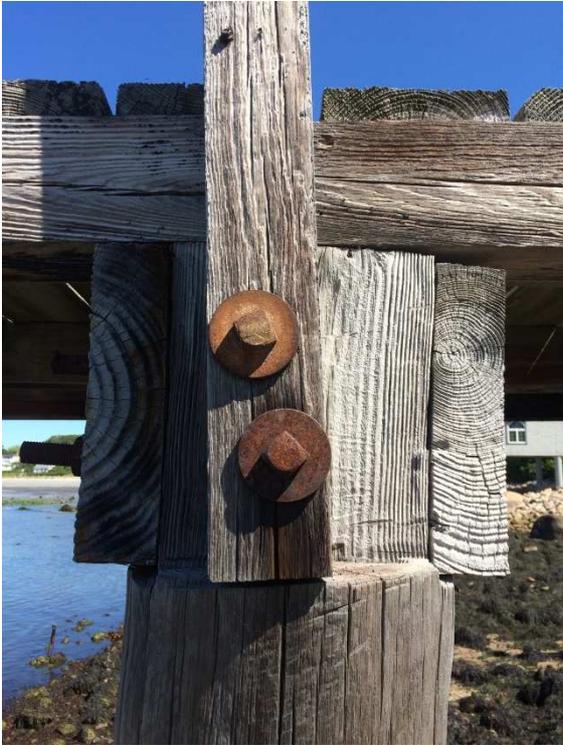
Client Name: City of Gloucester Harbormaster		Site Location: Magnolia Pier	Project No. 18.0172459.00
Photo No. 7	Date: 08/06/15

Direction Photo Taken: Northerly			
Description: Typical pier framing. Note: Split pile caps and rail post notched into timber pile.

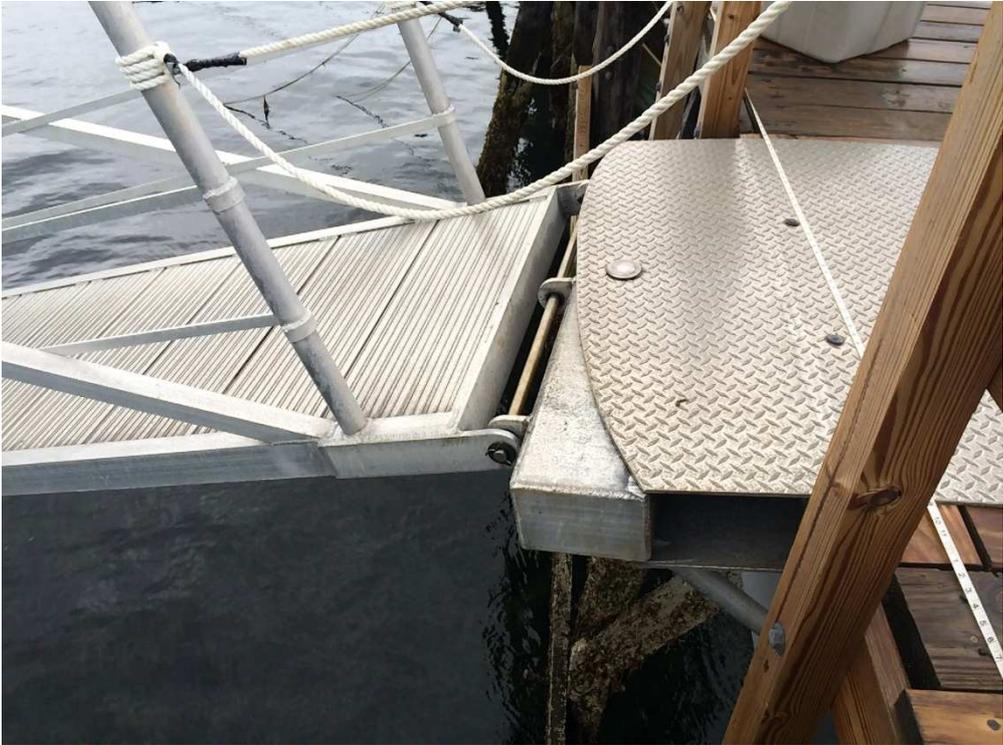
Client Name: City of Gloucester Harbormaster		Site Location: Magnolia Pier	Project No. 18.0172459.00
Photo No. 9	Date: 08/21/15

Direction Photo Taken: Easterly			
Description: Aluminum gangway connection.

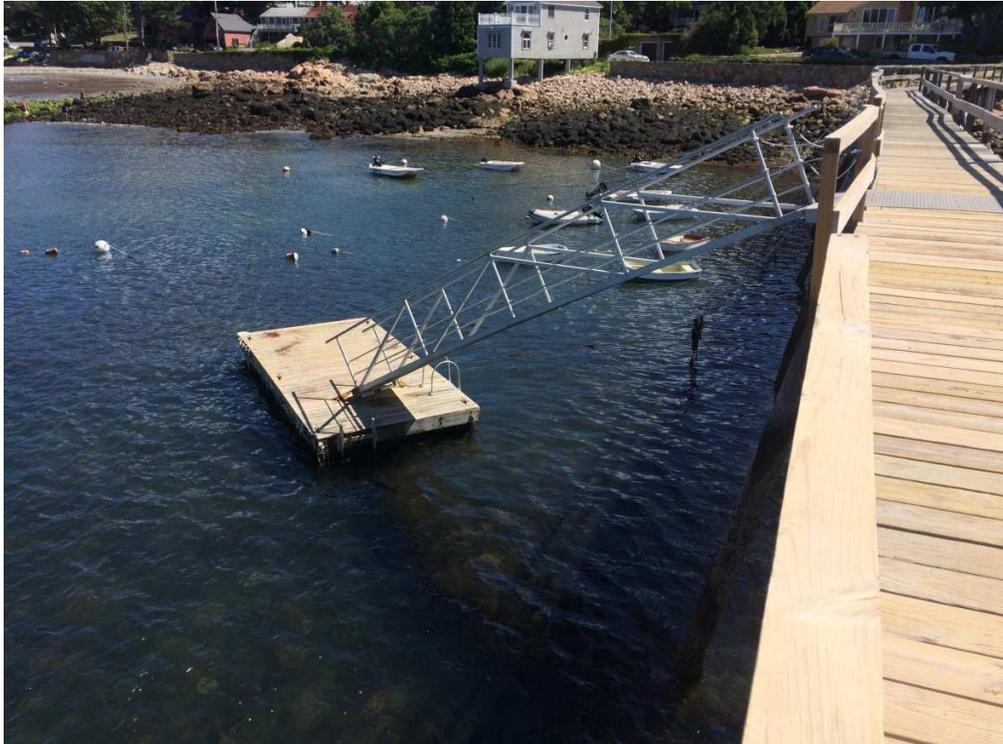
Photo No. 10	Date: 08/06/15

Direction Photo Taken: Easterly			
Description: Seasonal bottom-anchored timber float and aluminum gangway.

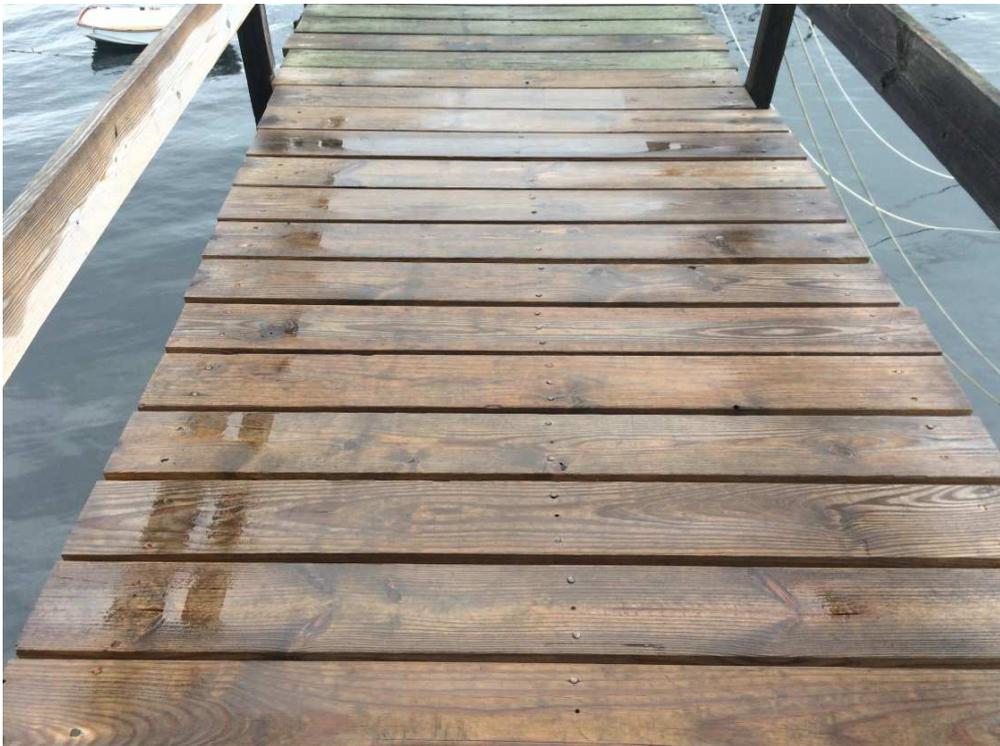
Photo No. 24	Date: 08/21/15

Direction Photo Taken: Westerly			
Description: Typical condition of newer decking members.
