CITY OF GLOUCESTER COMMUNITY PRESERVATION COMMITTEE PROJECT APPLICATION COVER SHEET

Stabilization of the Babson-Alling House (c. 1740), 243 Washington St., Gloucester, MA

**CONDITIONS ASSESSMENT REPORT
BABSON-ALLING HOUSE, 243-245 WASHINGTON STREET,
GLOUCESTER, MASS.**

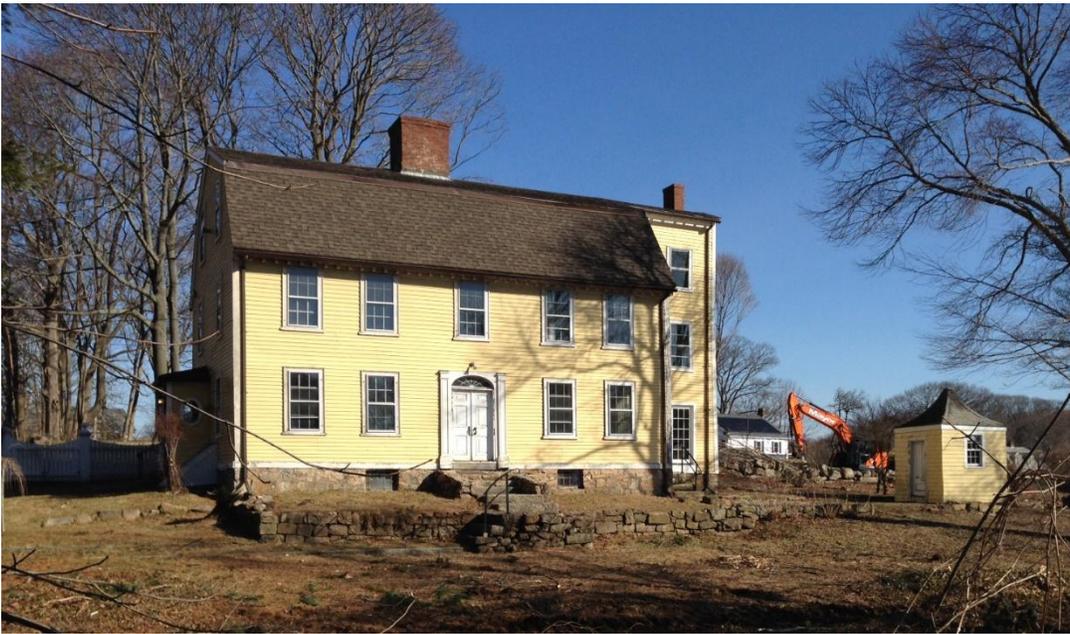
Figure 1. The south façade of the Babson-Alling House (c.1740) at the Cape Ann Museum Green as it looked in the autumn of 2019.

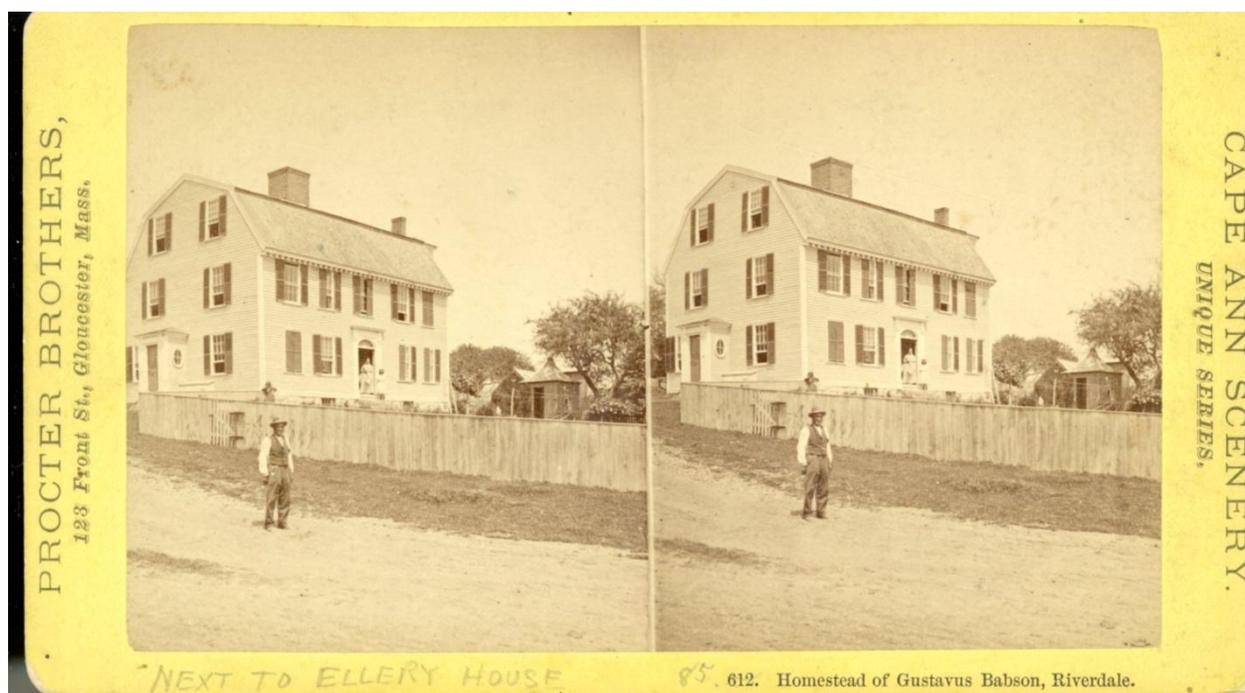
Figure 2: The Babson-Alling House, with Washington Street in the foreground, as it looked c. 1865.

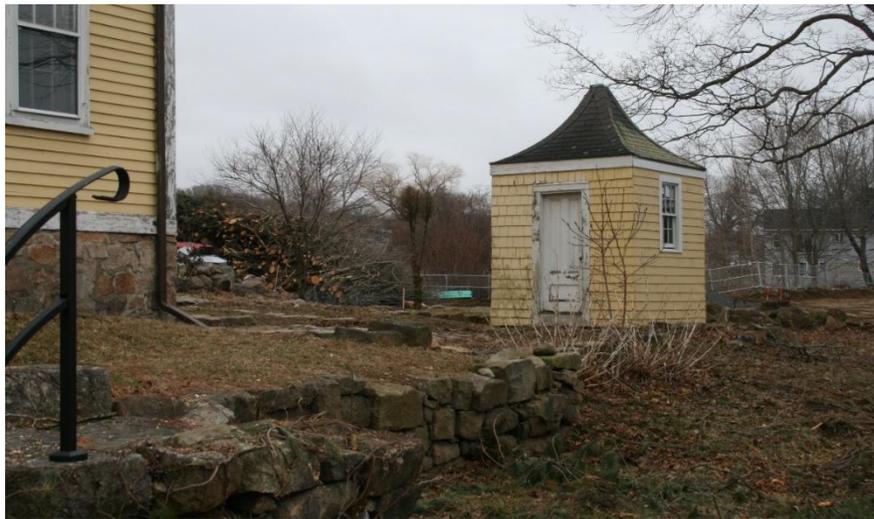
Figure 3. This privy, which is thought to date perhaps as far back at the House, stands adjacent to the Babson-Alling House and will receive stabilization work.

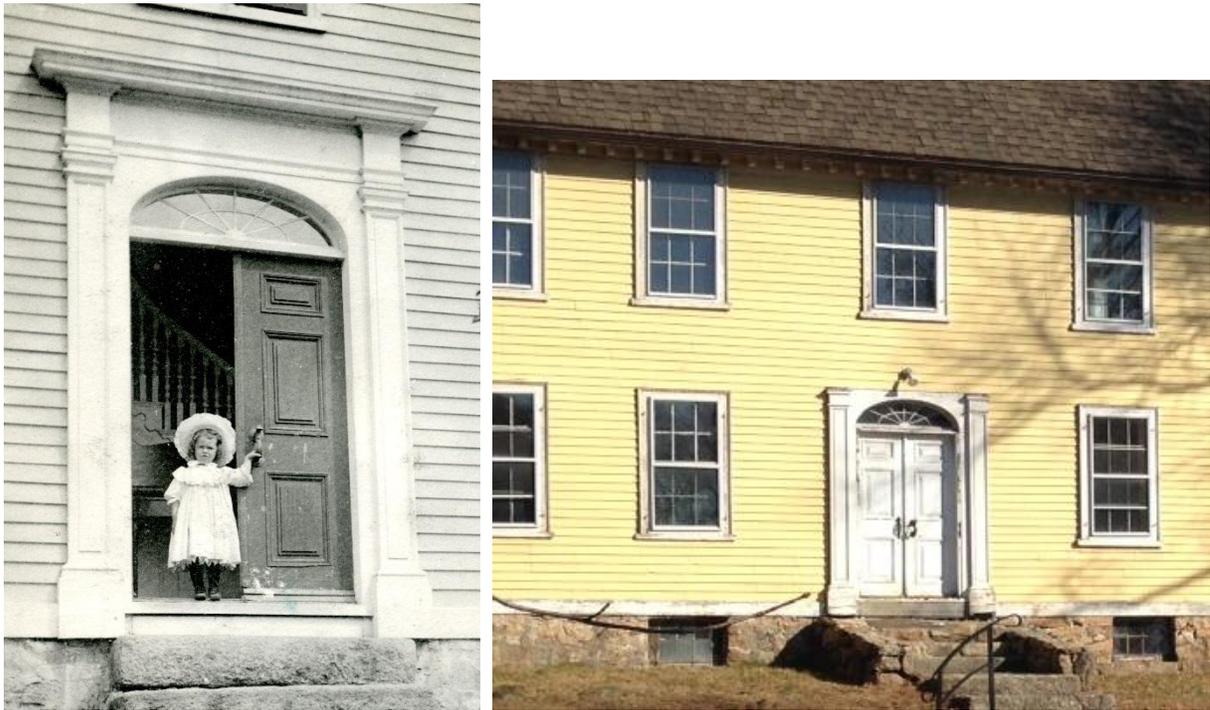
Figure 4. Stabilization work will be done to the front entrance to the Babson-Alling House. The image on the left was taken c. 1899; the image on the right was taken in 2019. A modern floodlight will be removed from above the door and the missing lintel replaced.

- Stabilization of the front entrance to the building which has been substantially altered and is currently in very poor condition. The door will be removed from the structure so that repairs can be done on it in the shop setting; all historic hardware will be reused. A Federal-era lintel over the door which was removed sometime during the early 20th century will be replaced, and the glass fanlight will receive much needed conservation work. The wooden columns that flank with door will also be preserved. (A modern spotlight over the entry will be removed.) Successfully completing this work will assure preservation of the entryway and vastly improve the historic integrity and appearance of the structure.
