CITY OF GLOUCESTER COMMUNITY PRESERVATION COMMITTEE PROJECT APPLICATION COVER SHEET

City Hall Fire Suppression, Alarm System and Electrical Upgrade

City Hall is an architectural and historic gem, which defines our skyline, anchors downtown, houses invaluable archives, WPA murals and other art and artifacts and has been the seat of municipal government since 1871. Our goal is to address the grave danger to the building, to Gloucester and to the surrounding neighborhood, should this iconic structure suffer a catastrophic fire. As recommended by the City's consultants as well as the Fire Chief, in order to minimize the risk of fire, City Hall is in urgent need of a new sprinkler system, as well as an upgrade to the existing fire alarm and electrical system.

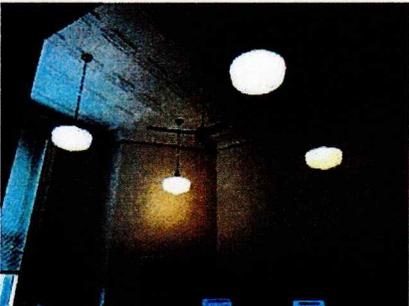
Image 18

The First Floor Hallway lighting consists of pendant chandeliers with screw-in LED bulbs and ceiling mounted spun aluminum cone fixtures with par lamps (Image 17 and Image 18). Corridor fixtures are controlled with centrally located switches within the Print Room.

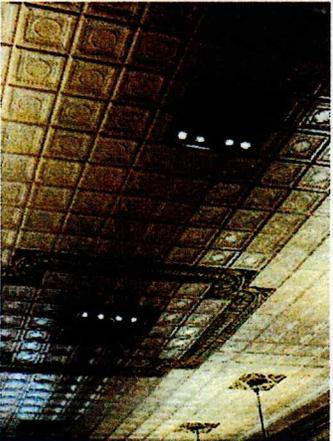
Image 21

The Second Floor Auditorium lighting consists of (8) pendant decorative bowl chandeliers with retrofitted LED sources. Fixtures are controlled with (1) switch. The (8) chandeliers are attached to (8) manual winches located in the Attic. Two clusters of (4) recessed adjustable gimbal fixtures are centrally located in the Auditorium (Image 21 and Image 22).

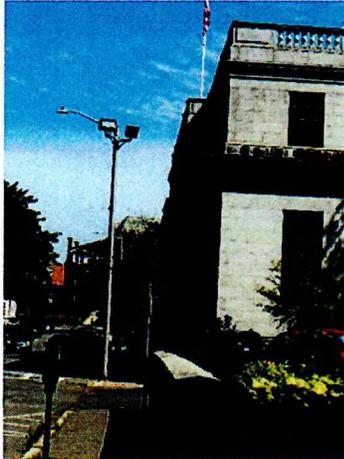
Image 24

The exterior lighting consists of two flood fixtures on poles, one pole at each corner of the lot. Some of the flood lights are used to graze building façade (Image 24).

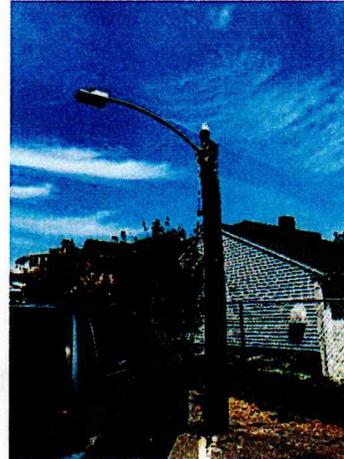
Image 25

The rear parking is lit with a 12 foot wooden pole with a cobra head. Parking areas are inadequately lit (Image 25).

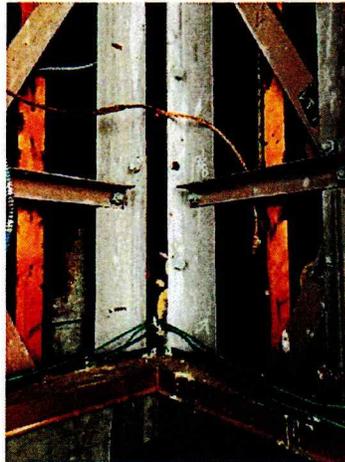
Image 26

The facility does not have a full lightning protection system. The Towers, however, have been grounded with a bare copper conductor interconnecting all the Towers and dropping with a down conductor to ground (Image 26).

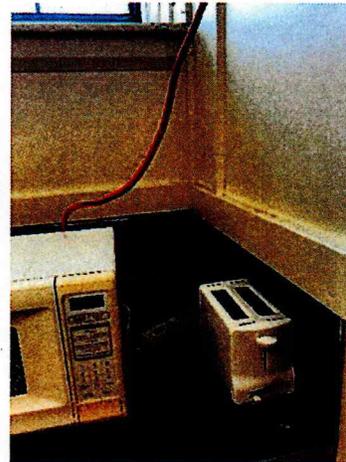
Image 27

The use of extension cords to replace permanent wiring is a code violation (Image 27).

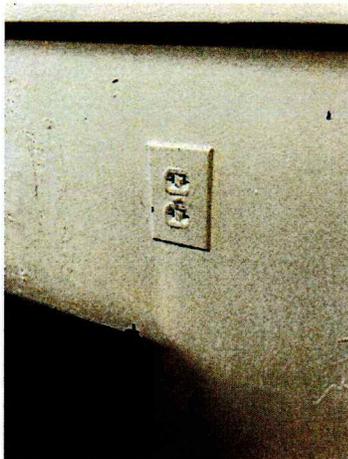
Image 28

Some receptacles were noted without grounding prongs (Image 28).

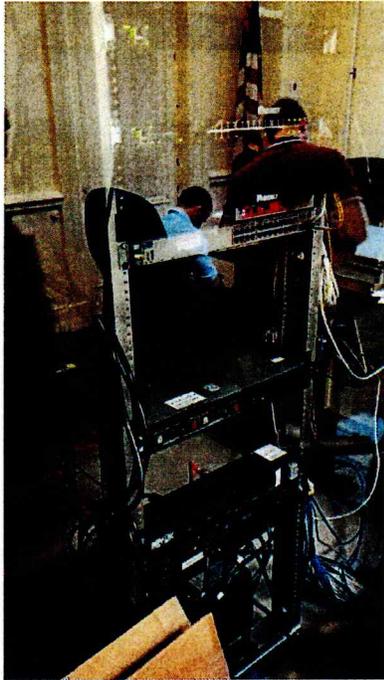
Figure 1—MDF Switch Rack

Older network cabling is installed throughout the building that primarily originates at one main distribution frame room location on the main level (Figures 1 and 2). The City has indicated that new network cabling is required throughout the building that may require additional wiring concentration centers or Intermediate Distribution Frame (IDF) room locations. One such IDF location was observed in the attic above the Council Chambers (Figure 4) and included a small wall mount enclosure with a network switch inside. Network cabling is running exposed in the Attic (Figure 3). The Main Distribution Room is adequate for any future cabling projects, but may need updating. Additional IDF's may be required so that any new structured cabling meets accepted networking standards. City Hall is on the City fiber optic network.

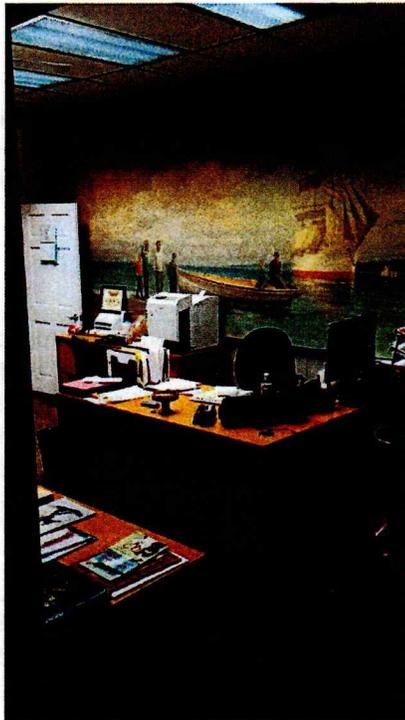
Figure 6—Office Computer Equipment

Desktop and laptop computers were observed and appear to be current level technology (Figure 6). City indicated that updating of current computers and printers is required. Large copier printers and workgroup printers (Figure 7) were observed in various administrative areas.

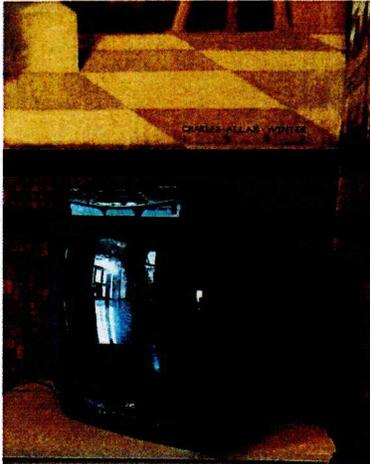
Figure 8—Older AV System

Three conference rooms in the building do not have up-to-date conference room level audio visual systems (Figure 8).

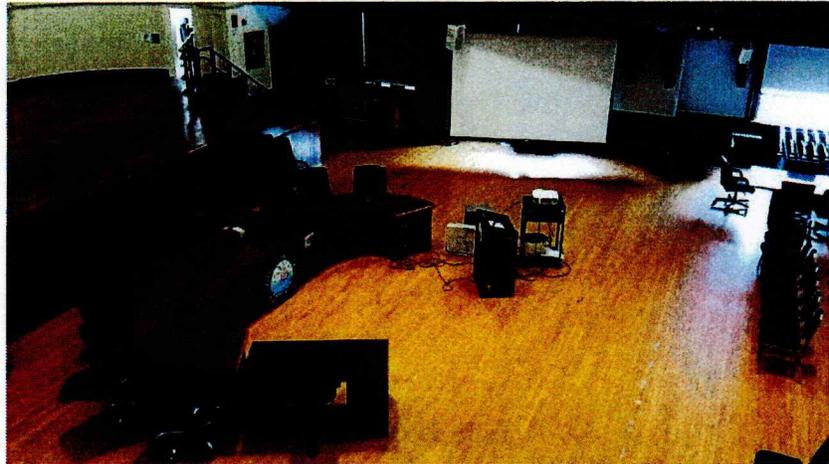
Figure 9—Council Chambers

The Main Council Chambers is equipped with chamber desktop microphone system, mobile projection system on a cart, and pulldown screen (Figure 9). The local audio system has speakers mounted under the balcony (Figure 10). There is one local CCTV camera at the rear of the space (Figure 11). Equipment appears inadequate for the size of the room, and a bit antiquated.

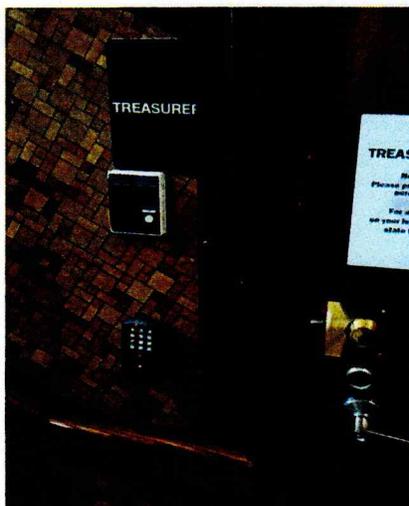
Figure 12—Access Control

Access control is limited to department areas such as the Treasurer’s Office (Figure 12). There are multiple alarm panels used to secure different areas of the building with associated keypads (Figure 13). There are only four surveillance video security cameras installed currently (Figure 14). One at each of the main entrances/exits.
