FORM A - AREA

Town/City: Gloucester

Name of Area: Parmenter, Rice & Co.
(a.k.a. Empire Fish Co.)

Date (month/year): d r a f t – June 2016

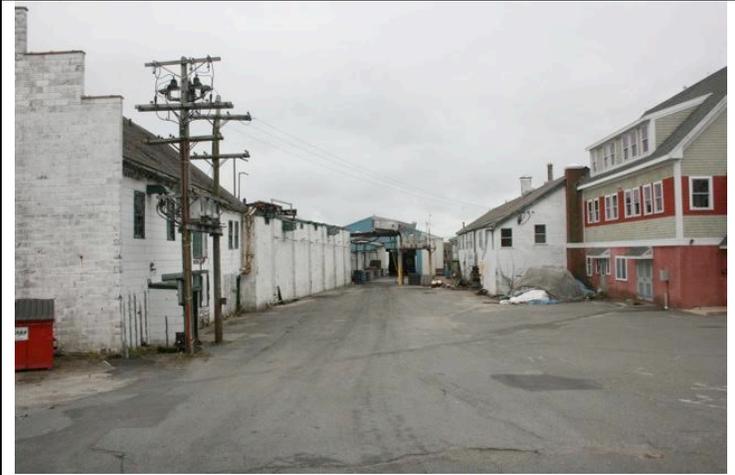
Photo 1. View southwest from Harbor Loop. L to R: Buildings 1, 3, 4, 5, 7, 8, 9.

Overall Condition: good to poor

Asbestos siding (M 20th c) - Siding, dormers, and fenestration at Bldg 9 (E 21st c)

The Parmenter, Rice & Co. Fish Ware House, Building 1 (ca. 1884-88, Photos 1, 2, 3), is a two-story wood frame structure with a gable roof aligned parallel to the courtyard. It measures 35 feet deep by 62 feet long. The building's courtyard façade (northwest elevation) is clad with asbestos shingles and features irregular fenestration, including loading bay doors on both the first and second floors. Windows on this wall consist of 6/6 double-hung sash with wood casings and band molding. A blank, concrete end wall with a stepped parapet faces Harbor Loop. Other elevations are not visible from the street.

The largest building on the site, Building 8 (Photos 1, 4, 8) is a rectangular block measuring 110 feet long by 32 feet wide. It rises 2 stories to a gable roof with wood fascia boards. Walls are clad with asbestos shingles on the courtyard façade and clapboards on the north elevation. Utilitarian industrial doorways are irregularly arrayed across the façade. Windows are typically paired 2/2 windows with band molded trim, regularly spaced across the top floor. An enclosed exterior stairway rises up the northern end of the courtyard façade.

The Parmenter, Rice & Co. Storage Building, Building 9 (ca. 1884-89, Photos 1, 2, 6), has been significantly renovated in recent years. Measuring 32 feet wide by approximately 48 feet long, it rises 2 ½ stories from a concrete foundation to an end gable roof with long shed dormers on each side. Of wood-frame construction, its walls are clad with wood shingles, including bands of decoratively patterned shingles at the second floor and the gable peak. Two doorways are located on the east façade of the ground floor level, beneath modern shed roof canopies, with four pairs of windows on the second floor. A modern, gabled pavilion on the north elevation contains the main entrance, beneath another shed-roofed canopy, and a stairway to the second floor. Windows are 1/1 replacement sash with flat casings. The 1993 MHC inventory form shows this structure looking more barn-like, with four single windows on the second floor of its façade, no dormers, irregular fenestration and an upper level entrance vestibule on the gable end, and two widely spaced single windows in the gable peak.

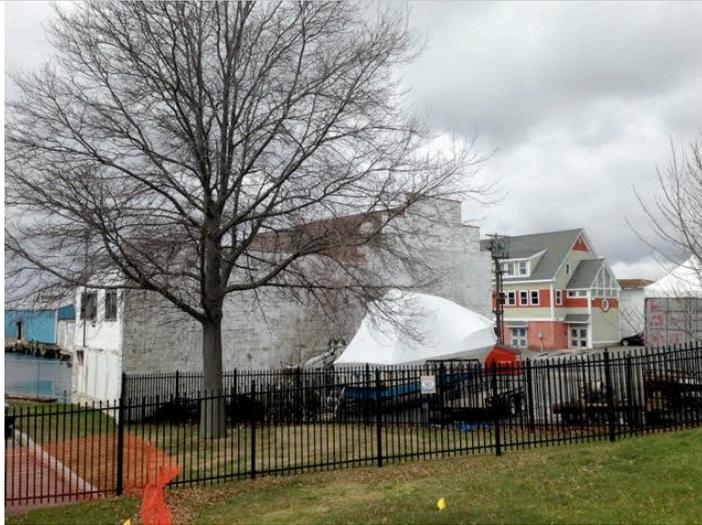
Photo 2. L to R: Buildings 2, 1, 9. View west.

Extending at a slight angle from the back of Building 1 is the Parmenter, Rice & Co. Fish House, Building 2 (ca. 1884-88, Photos 2, 3, 7), which reaches nearly to the adjacent Coast Guard property to the east; it measures 44 feet deep by 27 feet long (adjacent to Building 1). Building 2 rises two stories from a concrete foundation to a shed roof that is pitched down from the street edge. Its northeast elevation, facing Harbor Loop, is another blank concrete block wall. Its east elevation, facing the Coast Guard property, is sheathed with asbestos siding and contains one pair and one triplet of windows on its second story, which appear to contain 6/6 double hung sash and wood casings with band molding. Other elevations are not visible from the street.

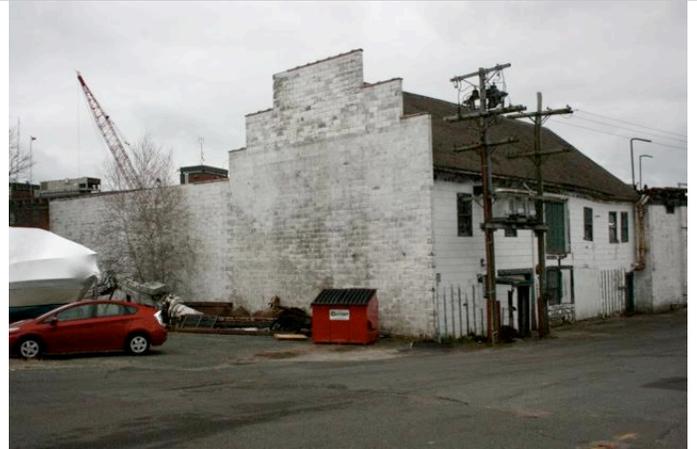
Photo 3. Building 1, northeast (façade) and northwest elevations.

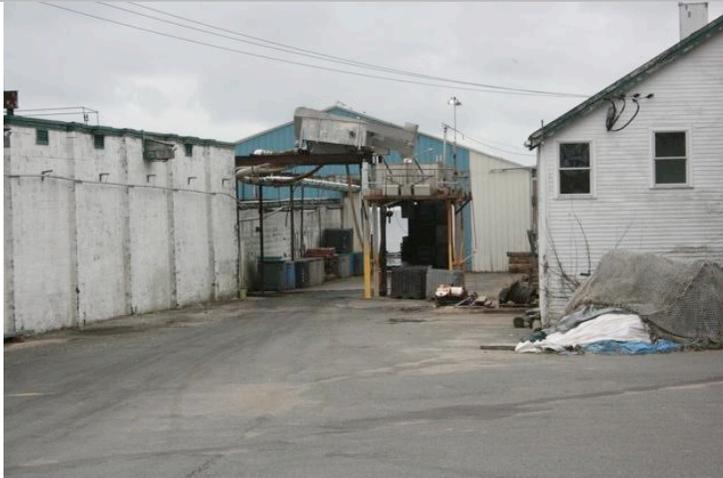
Photo 4. L to R: Buildings 3, 4, 5, 8. View southwest.

Seven bays long, the Empire Fish Co. Fish Packing Building, Building 3 (ca. 1917-49 and ca. 1949-60, Photo 4), is constructed of concrete block with prominent piers marking the bays. Measuring 37 feet deep by 104 feet long, it rises a tall one story and culminates in a flat roof with a layering of flat wood fascia boards. There is no fenestration on its courtyard (façade) elevation.

Another Empire Fish Co. Fish Packing Building, Building 4 (ca. 1917-49, Photos 4, 7), is a relatively small, utilitarian, wood frame building clad with asbestos siding. It rises one story to a flat roof. Its only visible fenestration is a large, open entrance at its far north corner, adjacent to Building 3. The back (southeastern) portion of the building extends over the harbor, supported on wood piles.

The Empire Fish Co. Fish House, Buildings 5 and 6 (ca. 1917-49), terminates the inner courtyard of this complex. Building 5 (Photos 4, 7, 8, 9) consists of a steel frame structure sheathed with corrugated metal panels and a steeply pitched, front-gable roof. This large structure appears to be set completely over the water, supported by concrete piers and buffered by wood piles. The northeast (façade) elevation contains a large, open vehicular entrance that is set off-center. The floor inside is concrete.

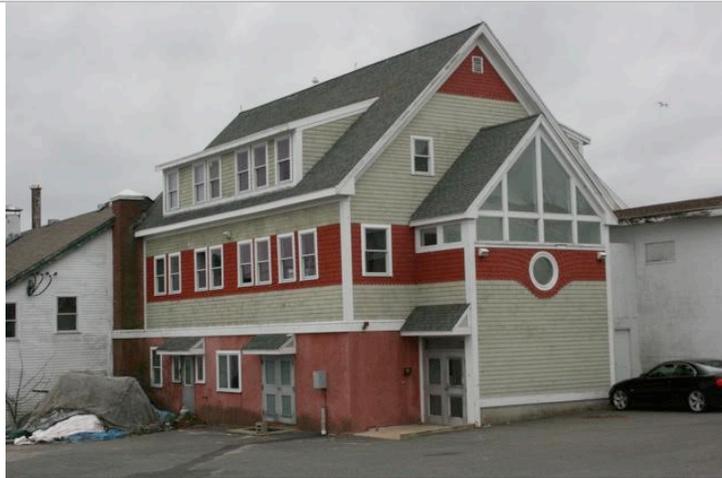
Photo 6. Building 9, southeast (façade) and northeast elevations.

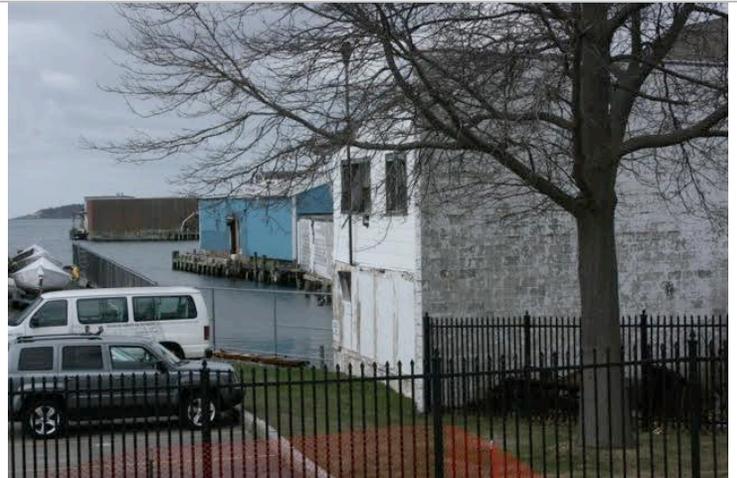
Photo 7. L to R: Buildings 6, 5, 4, 2. View southwest.

Building 6 (Photos 7, 8, 9) extends from the back of Building 5 into Harbor Cove. Similarly constructed with corrugated metal panels but with a lower-pitched gable roof, this structure too is set over the water on concrete piers. It is edged with a narrow wood deck at its outer gable end and is buffered with wood piles on three sides. Together (as they are depicted on the assessors' maps), Buildings 5 and 6 together measure 64 feet wide by 104 feet long.

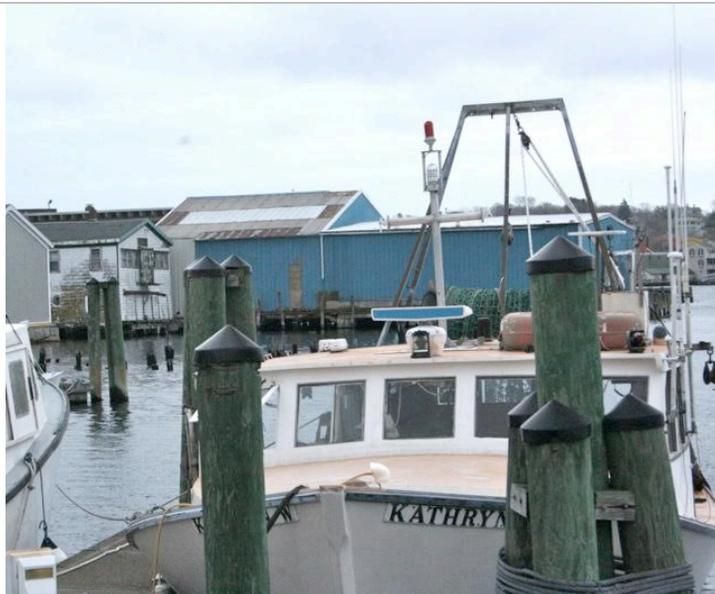
Photo 8. L to R: Buildings 7, 5, 6. View northeast.

A narrow gap (once closed by an infill structure) separates Building 5 from the Empire Fish Company Packing Building, Buildings 7 and 8 (ca. 1917-49). Building 7 (Photo 8) is a relatively short block measuring 32 feet deep by approximately 40 feet long. This wood frame structure rises two stories to a shallow-pitched gable roof with boxed wood eaves; it is sheathed with wide clapboard siding on the interior and possibly with wood shingles on the harbor-side elevations. Fenestration includes a door on the second level of the courtyard elevation, accessed by a utilitarian wood stairway, and irregular 1/1 windows, some of which are paired. The south elevation contains a band of windows at the upper level and what appears to be a variety of hoisting devices. The southern end of this structure is propped out over the harbor on wood piles and beams.

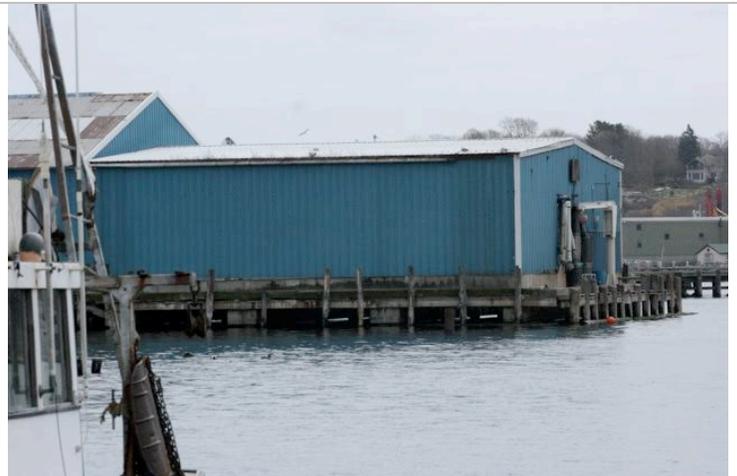
Photo 9. Building 6. View northeast.
